APM Tunnel Extension for the Maynard H. Jackson Terminal at Hartsfield-Jackson Atlanta International Airport

Adam S. Hurley¹, P.E. and W. Morgan NeSmith², M. ASCE, P.E.

ABSTRACT: Hartsfield-Jackson Atlanta International Airport underwent a \$1.2 billion dollar expansion project centered on the construction of the new Maynard H. Jackson International Terminal. Since completion, all international operations have transferred to the new terminal. The new International Terminal has its own pick-up and drop-off access, baggage claim and check-in facilities; as well as parking facilities. Passenger access between the new International Terminal and the domestic airport facilities is primarily via underground Automated People Mover (APM) trains.

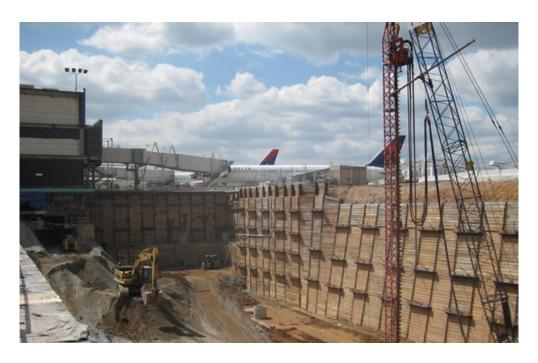
FIG 6. Completed Excavation Support of Taxiway Dixie

The alternate approach for shoring included installing shoring, where possible, with a top-elevation 10-ft below finished grade to eliminate the need for shoring cutoff but included some demolition of the existing taziway before completion of the work. Additoinally, the soldier piles were installed on a 10-degree batter to reduce earth pressures to allow for the use of smaller piles, fewer tiebacks and less pile-toe penetration below bottom of excavation. A schematic of the alternate approach is shown in Figure 5. A photo of the completed work is shown on Figure 6.

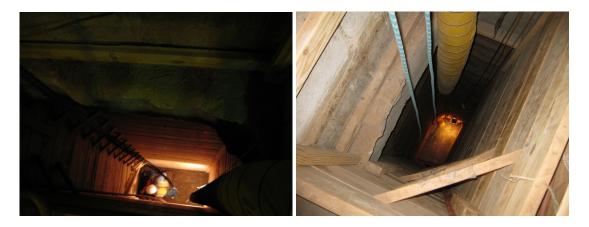
FIG 13. Pit Construction and Subsequent Concrete Filling

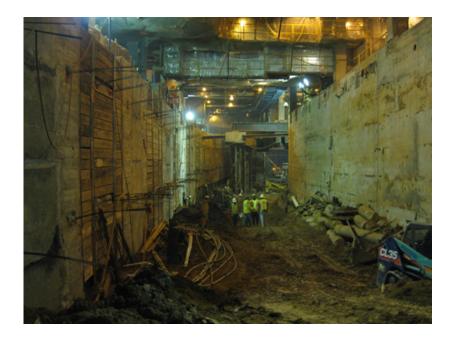
FIG 14. Completed Excavation Support System Under Concourse E

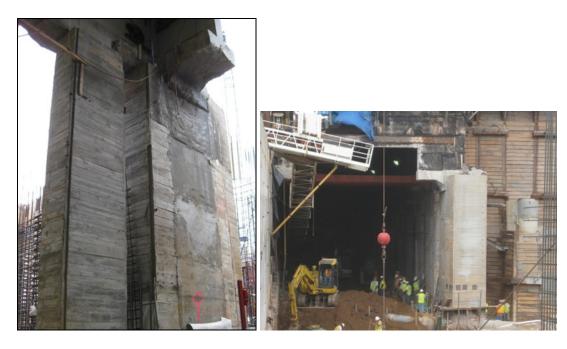
FIG 15. Exposed Underpinning Pits After Excavation

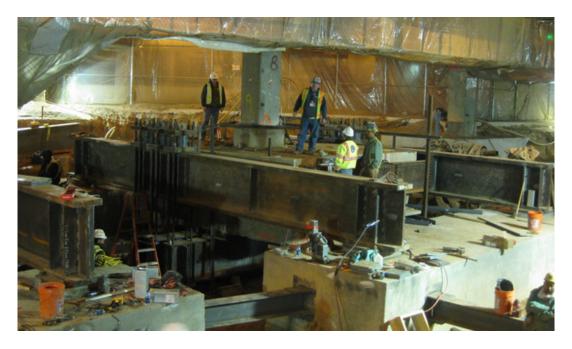
FIG 20. Overview of Load Transfer System from Existing Columns to New Caps

Column loads were transferred to the micropiles and the conflicting APG piles were removed. Figure 19 shows the exposed existing APG pile which were removed along with the same view after completion of the steel load transfer system connecting the existing columns to new caps on the installed micropiles. Figure 20 is a global view of the load transfer system. The steel was eventually encased in concrete during tunnel construction. Figure 21 is a view of the completed excavation showing the existing caps, load transfer system and new micropiles.

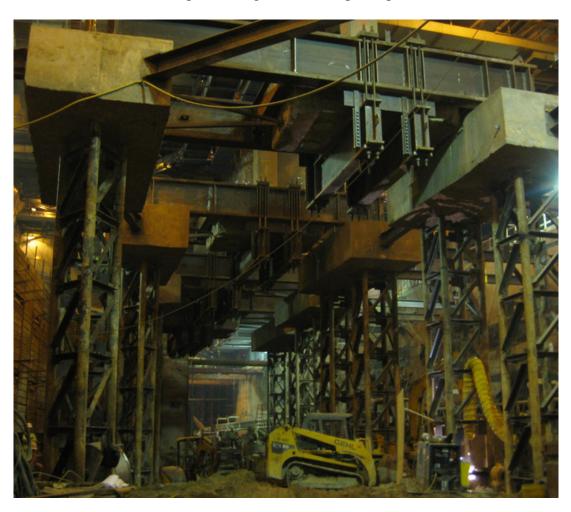
FIG 21. Post-excavation View of Supported Columns Under Concourse E
