## **UNDERPINNING ATLANTA INTERNATIONAL AIRPORT CONCOURSE E FOR APM TUNNEL EXPANSION**

Adam S. Hurley, P.E., Berkel & Co. Contractors, Inc., P.O. Box 335, Bonner Springs KS  
Clinton O. Rex, P.E., Stanley D. Lindsey and Associates, 2300 Windy Ridge Parkway SE, Atlanta GA  
Daniel S. Stevenson, P.E., Berkel & Co. Contractors, Inc., 200 Bailey Drive, Stewartstown PA  
W. Morgan NeSmith, P.E., Berkel & Co. Contractors, Inc., 7300 Marks Lane, Austell, GA

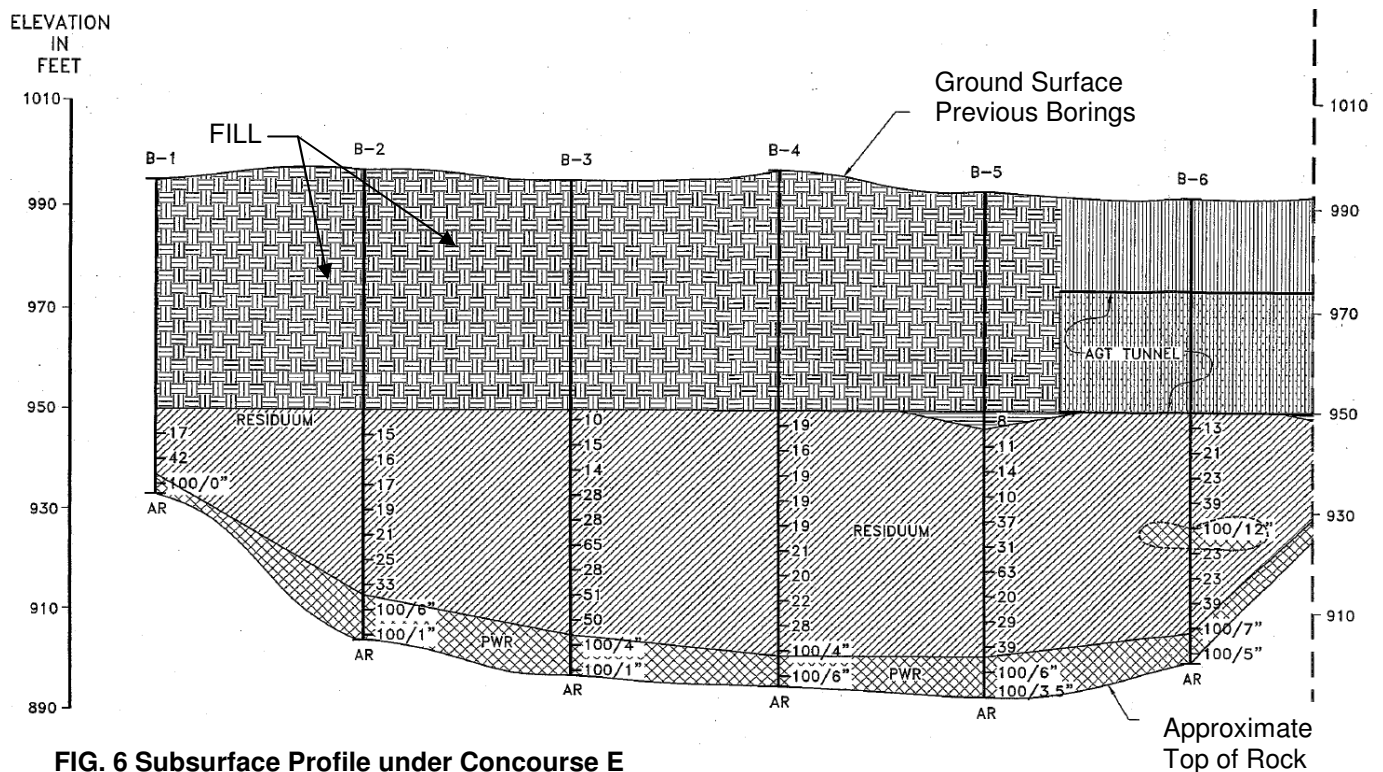
**FIG. 6 Subsurface Profile under Concourse E**

variability of residual soil, PWR, and rock elevation and thickness was a significant factor in the selection of the excavation method. A profile of the subsurface conditions under Concourse E is shown in Figure 6. A schematic of the conditions at the boring nearest the area of interest is shown in Figure 7.

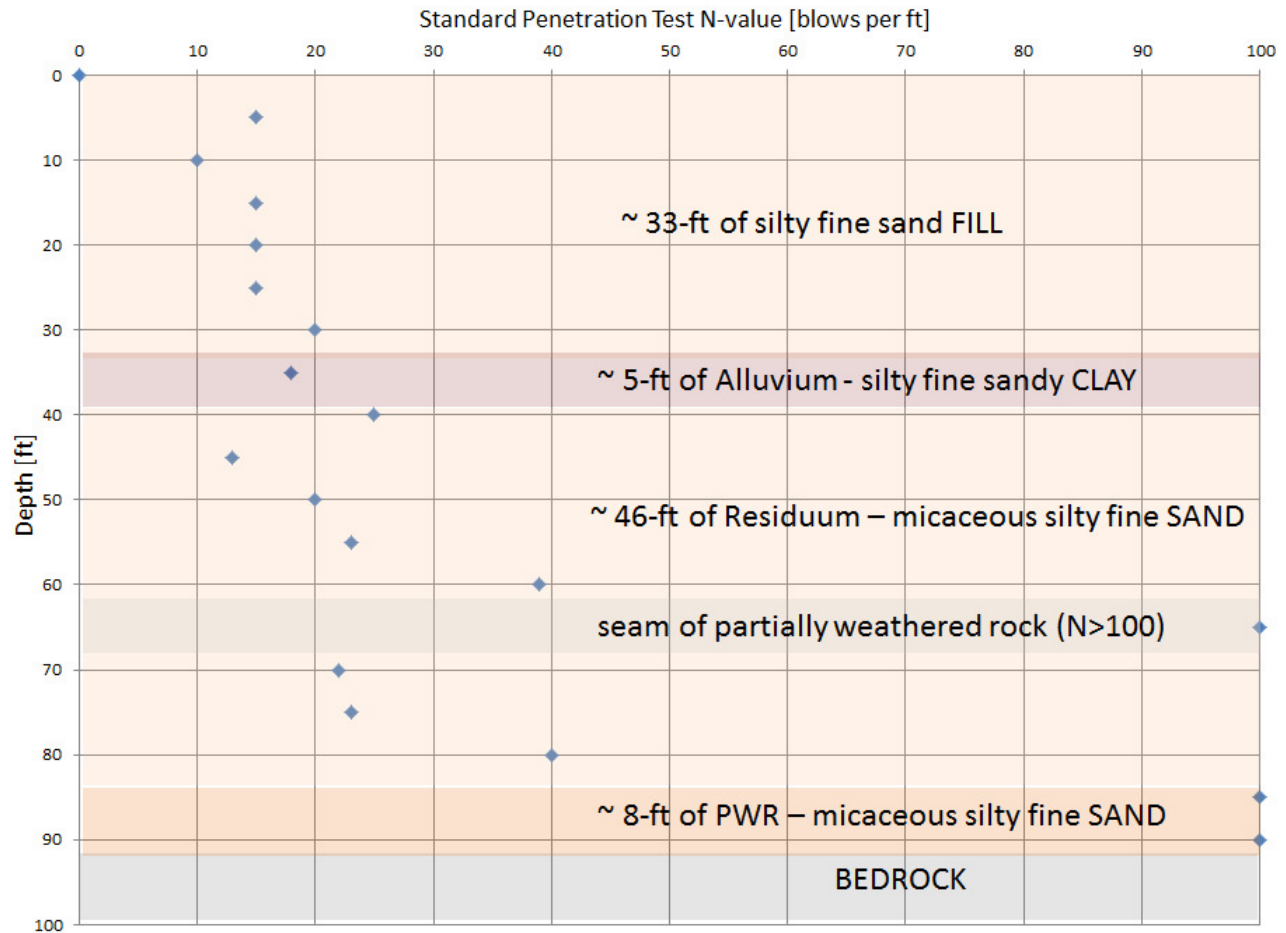
**FIG. 7 Generalized Profile in Boring Nearest Area of Interest**

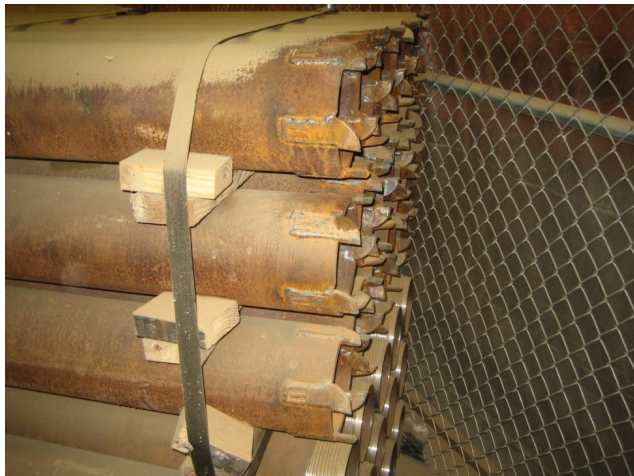
**FIG 12. 7-in diameter micropiles**

The final approach included 60 new micropiles, installed straddling the new train extension. Micropiles with an outside diameter of 7-in (Figure 12) were selected to support design compressive loads of 56-tons to 150-tons. Preliminary micropile design considered a rock socket of 15-ft to resist these loads.

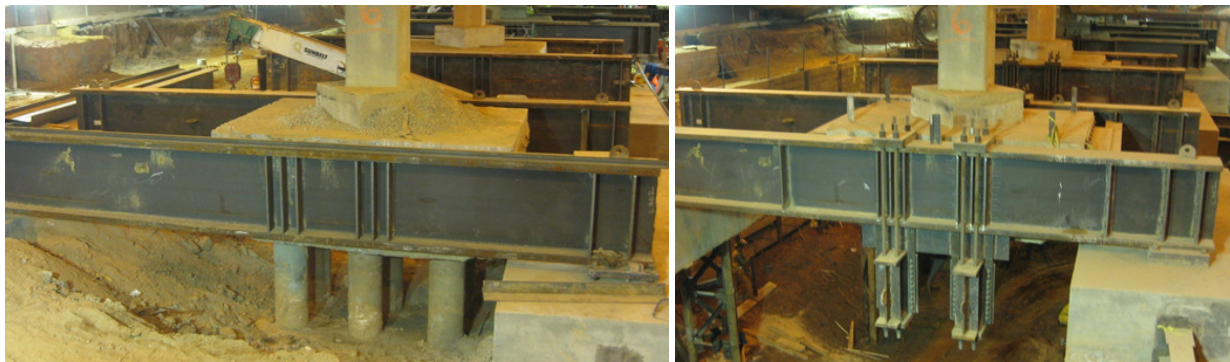
FIG 14. Before (with exposed APG piles) and After View of Column Support Below Concourse E

Column loads were transferred to the micropiles and the conflicting APG piles were removed. Figure 14 shows the exposed existing APG pile which were removed along with the same view after completion of the steel load transfer system connecting the existing columns to new caps on the installed micropiles. Figure 15 is a global view of the load transfer system. The steel was eventually encased in concrete during tunnel construction. During the load transfer process, a series of hydraulic rams were placed along the steel cross-beams at each connection to the beams under the cap. Reference beams and dial gages were arranged to monitor column movement during load transfer (Figure 16). Upward pressure was applied to the column through the rams until slight upward movement (< 0.1-in) was observed. The APG piles were then cut in sequence as numbered in Figures 8 and 9. During the removal of the APG piles the column deflections were monitored and additional upward pressure was applied as needed. Column deflections did not exceed 0.1-in below the original level at the start of the operation. Figure 17 is a view of the excavation in progress and Figure 18 is a view of the completed excavation showing the existing caps, load transfer system and new micropiles.

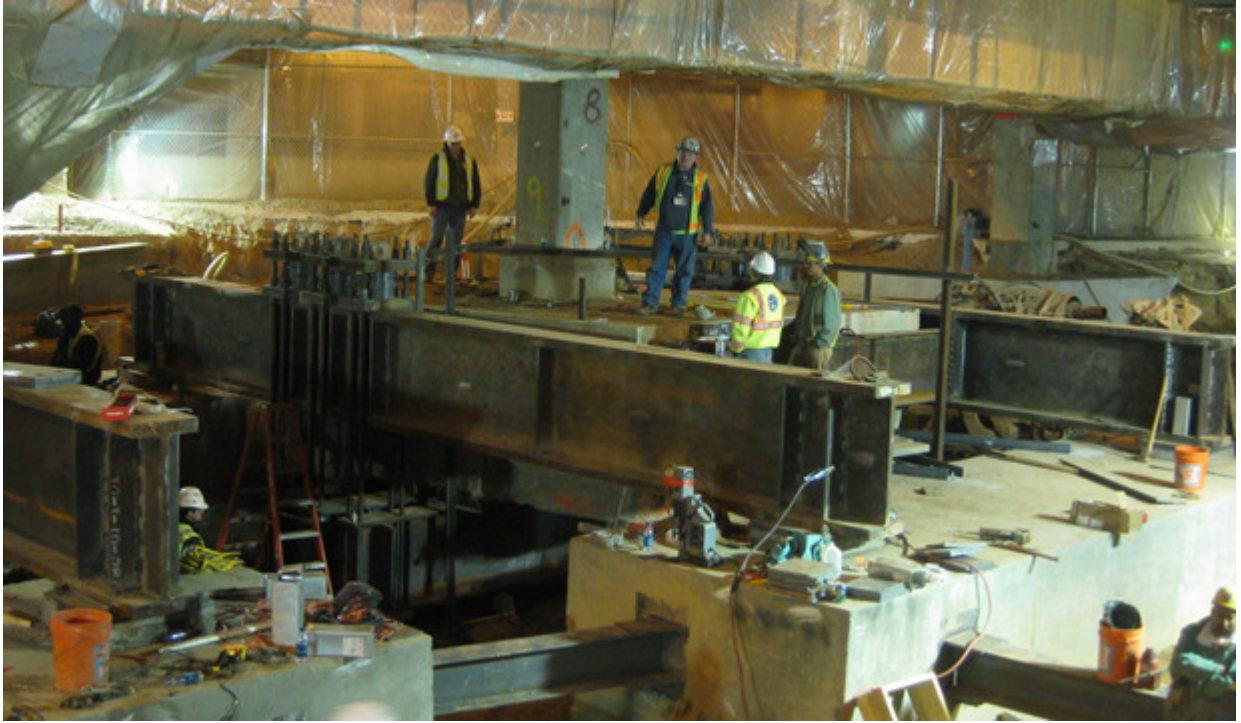
**FIG 15. Overview of Load Transfer System from Existing Columns to New Caps**

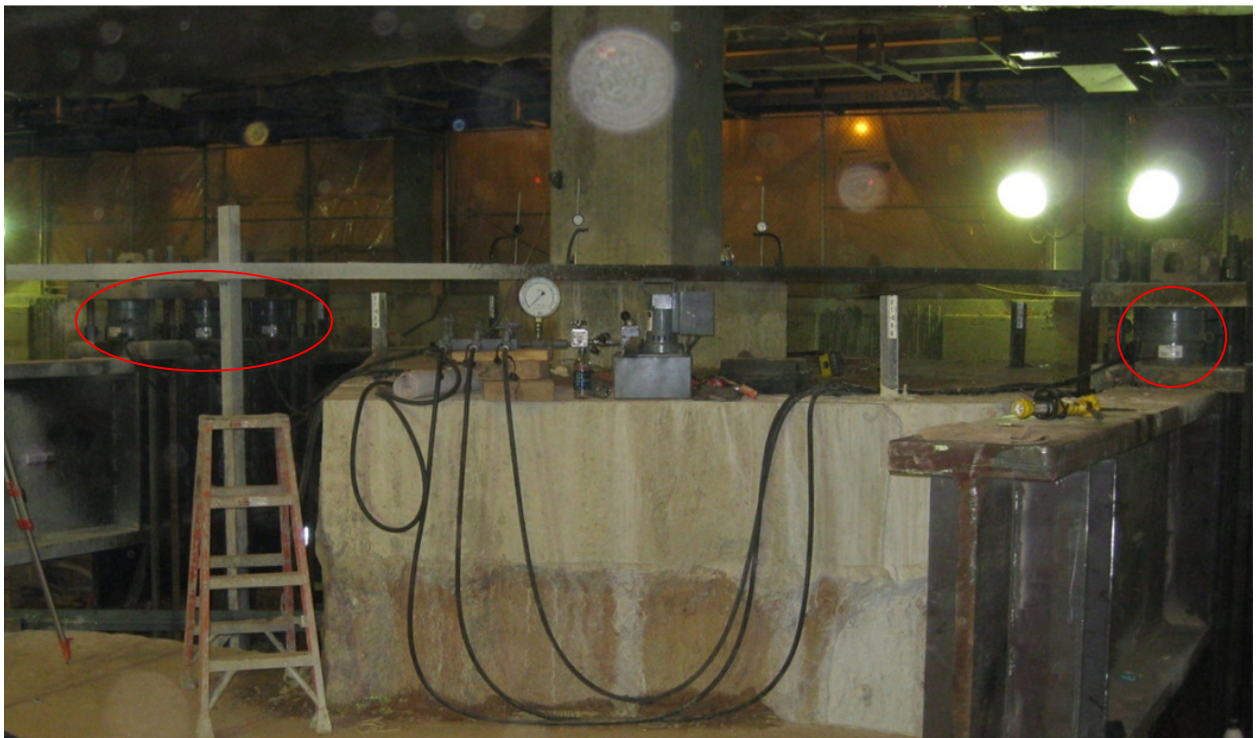
**FIG 16. Monitoring Column Deflection during Load Transfer to Micropiles (hydraulic rams circled in red)**

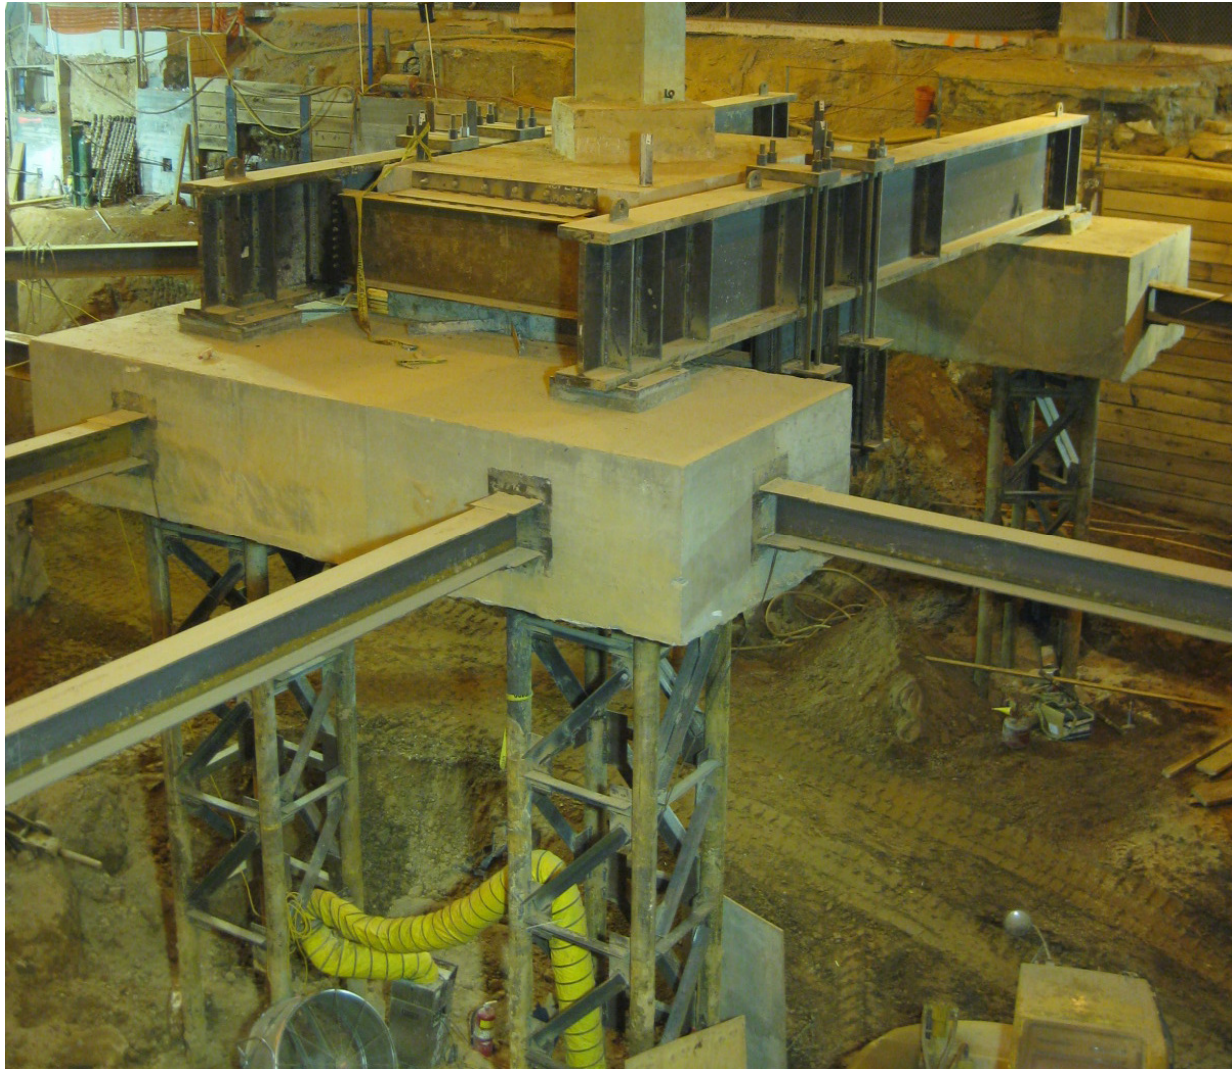
**FIG 17. Mid-excitation View of Supported Columns Under Concourse E**

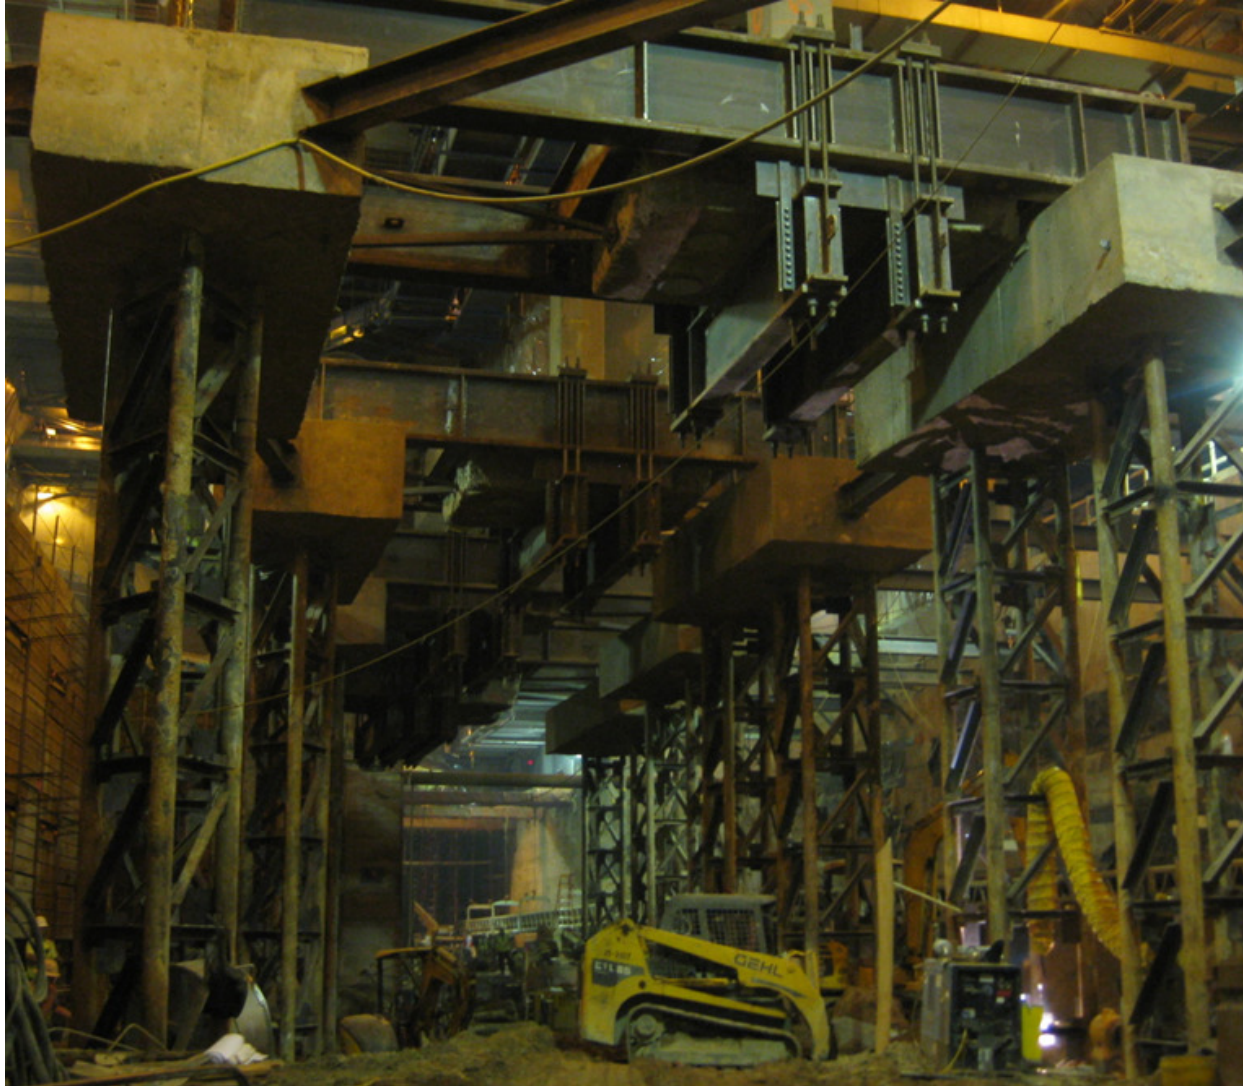
**FIG 18. Post-excavation View of Supported Columns Under Concourse E**

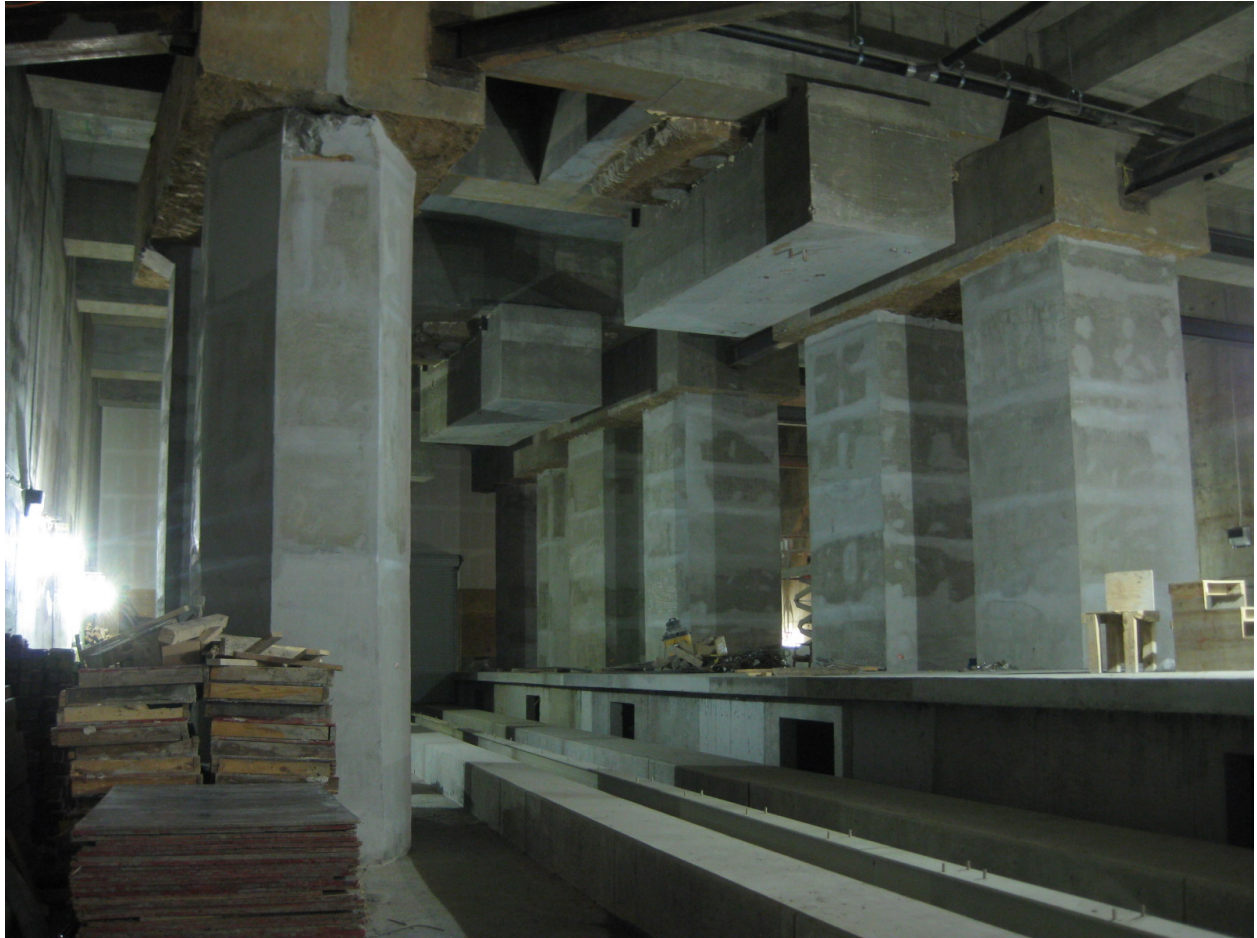
**FIG 19. Completed Micropile Columns Encased in Reinforced Concrete**

It is noted that the compression loads per micropile are static. The new micropile caps are laterally braced to resolve lateral loads on the new pile groups. They have also been cast in reinforced concrete for fire protection and protection against potential train impact (see Figure 19).
