University of Virginia Jefferson Rotunda Rehabilitation

Robert Bergwall, P.E., Daniel Stevenson, P.E., Morgan NeSmith, P.E., Berkel & Company Contractors

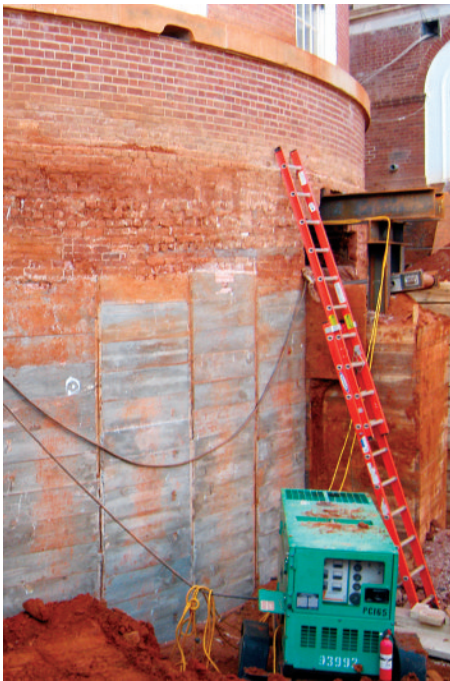
Exposed hand excavated underpinning pits

The finished floor elevation of the new basement for the mechanical room was 10 ft to 14 ft (3 m to 4.3 m) below the interior finished floor and existing site grade. Interior and exterior brick masonry walls, dating back to the original construction in the early 1800s as well as subsequent restorations in the mid and late 1800s, were supported with continuous underpinning shafts. These shafts were hand dug to depths up to 18 ft (5.5 m) below finished-floor level. The shafts were reinforced, filled with 4,000 psi (27.6 MPa) strength concrete, and dry packed for completion.

The condition of the brick and mortar was extremely poor in many locations. The project team was concerned that bricks could loosen and fall during the underpinning process, comprising a significant safety risk. As excavation of each

pit commenced, a temporary wood shelf was constructed to provide support for the existing brick footing and protect the workers below. Berkel constructed 94 pits, and the total excavated soil volume was approximately 730 cu yd (560 cu m).

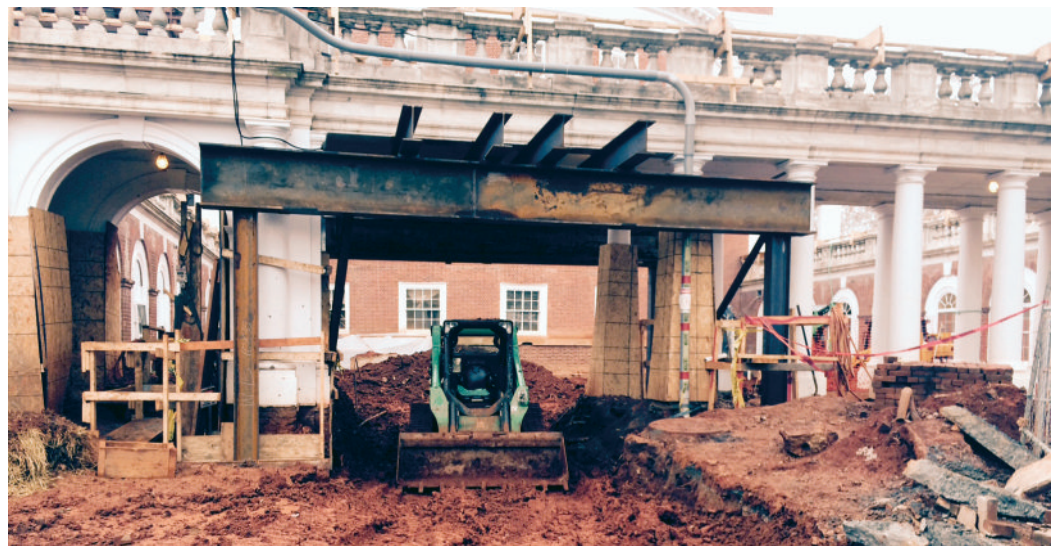
Needle beams for column removal

To create an access point with about 10 ft (3 m) of width and headroom, Berkel installed needle beam support for a section of the colonnade breezeway roof structure. This allowed limited columns to be removed by others providing sufficient access for a Boart Longyear tieback drill to

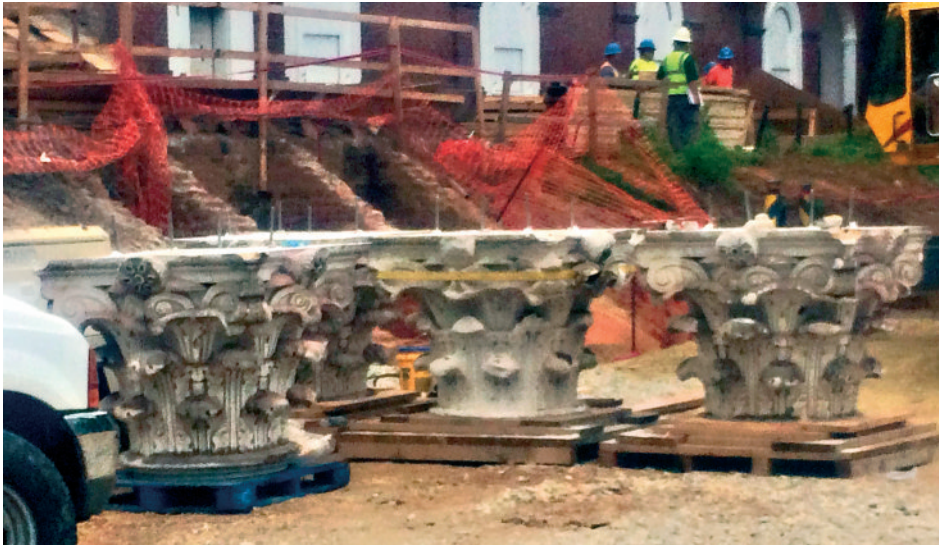
New capitals for north and south portico

The second phase will cost \$42.5 million and consists of significant structural changes. These include replacing the north and south portico roofs, replacing the Dome Room ceiling, constructing an underground room to house mechanical systems, and adding new marble capitals supporting the north and south porticos.

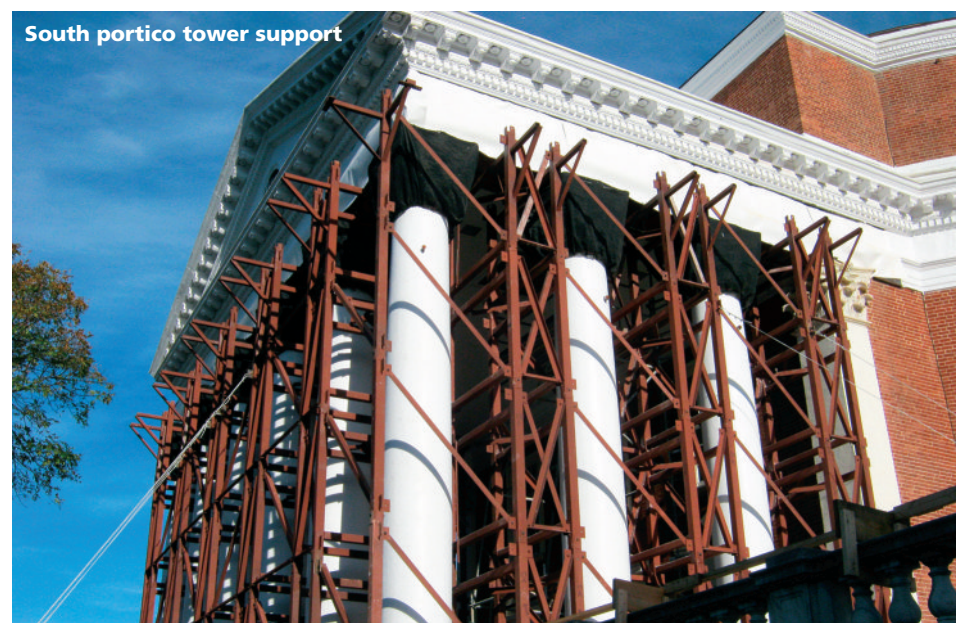
South portico tower support

Berkel's structural engineering team designed eighteen 3 ft by 7 ft plan (0.9 m by 2 m) by 30 ft (9.1 m) tall tubular towers. The tower design was coordinated with the elevated track trolley system used by Rugo Stone to remove and reinstall the new capitals. Each tower weighed approximately 2,500 lbs (11.1 kN) and was designed to limit the bearing stress to under 200 psi (1,380 kPa) to avoid distress to the aged foundation. In addition, deflections were limited to 0.13 in (3.2 mm) under all loading conditions. To achieve this, the towers were designed and constructed with adjustable screw legs. Once the needle beams were installed, the towers were hydraulically jacked, as required, to offset deflection and remain within project deflection limits. Berkel subcontracted Clemons Fabricators out of Richmond, Va., and ADD Equipment from Gretna, Va., for the fabrication and tower erection work.

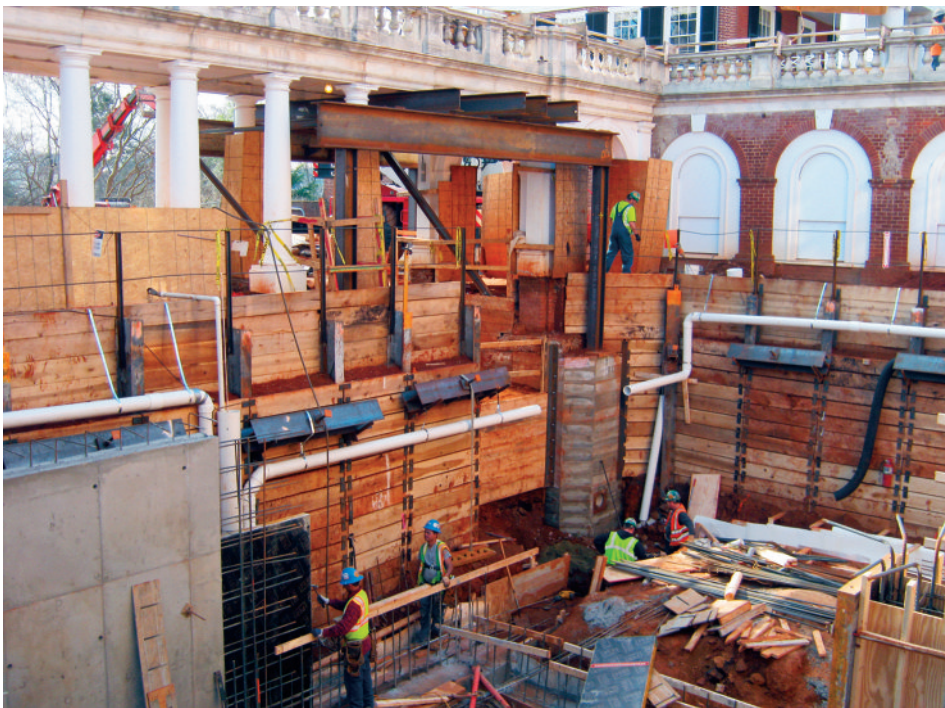
Temporary shoring

The exterior east courtyard excavation required three-sided temporary support within 5 ft to 7 ft (1.5 m to 2 m) of the northeast and southeast terrace office structures located just east of the Rotunda. The at-grade historic brick structures along with a marble colonnade breezeway to the east of the proposed excavation were supported without concrete pit underpinning. The contract documents called for a subcontractor-designed-and-constructed

temporary excavation support system consisting of drilled soldier piles, timber lagging and interior bracing. This was all to be constructed in an area with no open access for equipment other than by heavy crane lift. The contract documents also set the maximum allowable differential settlement between adjacent structure monitoring points at 0.25 in (6.4 mm) to prevent cracking in the historic brick for all project areas.

gain access to the courtyard. In lieu of drilled soldier piles, Berkel augered 16 in (406 mm) diameter holes on 5 ft (1.5 m) centers and installed wide-flange soldier beams in each augered hole. The space between the soldier piles and the sides of the augered holes was backfilled with lean-mix grout. The design team also approved the proposed alternate to the interior bracing called for in the contract documents. Berkel was given permission to install temporary tiebacks in lieu of the interior bracing to eliminate future conflicts with excavation and concrete operations. Lateral support of the soldier-pile and lagging system was provided by one level of temporary, post-grouted bar anchors.

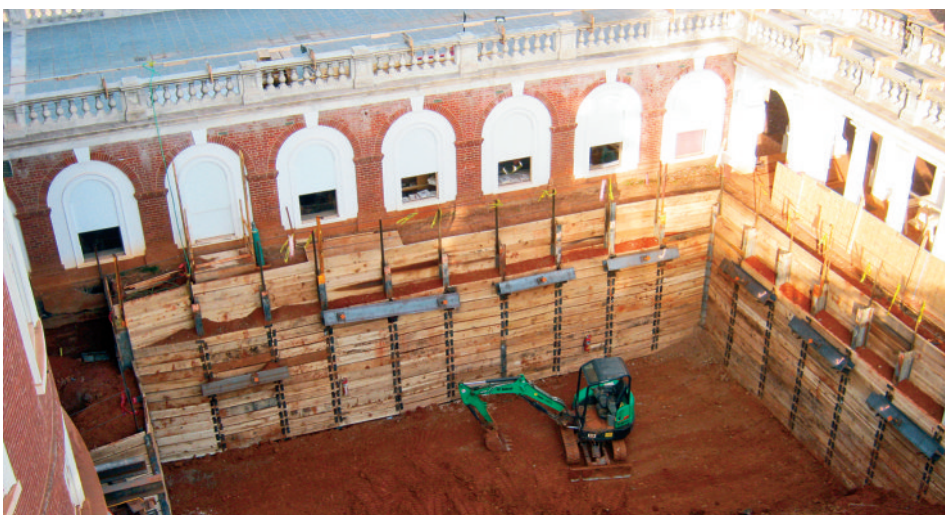
An overhead view of the excavation support
