500 Walnut Street: High-Capacity Auger Pressure-Grouted Piles Used to Support a 26-Story, Multi-Family Tower Behind Independence Hall

The purpose of this case history is to showcase the viability of high-capacity auger pressure-grouted (APG) piles as an alternative to the traditional deep foundation systems commonly used within the Philadelphia region (e.g. drilled shafts or caissons; driven piles; micro-piles). This case history demonstrates that relatively high capacities can be developed using APG piles when installed in similar geologic settings as the subject site and highlights the circumstances where APG piles may be a favorable alternative. Included is a brief summary of the 500 Walnut Street multi-family residential development, geologic setting, and process of how APG piles were selected and implemented for support of the proposed tower. Explanations are included demonstrating how the designers of the APG piles arrived at the theoretical pile capacities. Finally, this paper summarizes the results of a pile load test program used to confirm the recommended pile capacities, as well as experiences during the installation of production piles.

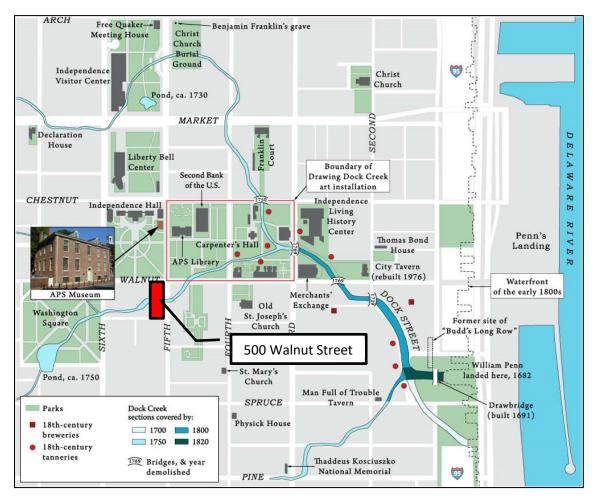
Figure 2. Illustration of 500 Walnut Street site location with respect to Dock Creek (APSM 2014).

While researching the site geology and related history, the Geotechnical Engineer identified the site as being situated above an historic branch of the former Dock Creek. According to published documents obtained from the American Philosophical Society Museum (APSM) and the Philadelphia Water Department (Figure 2), this branch of Dock Creek underlying the site was buried by the year 1750. Dock Creek was evidently surrounded by marshes prior to this time. Historic structures at the site had been previously demolished and backfilled long before the current development.

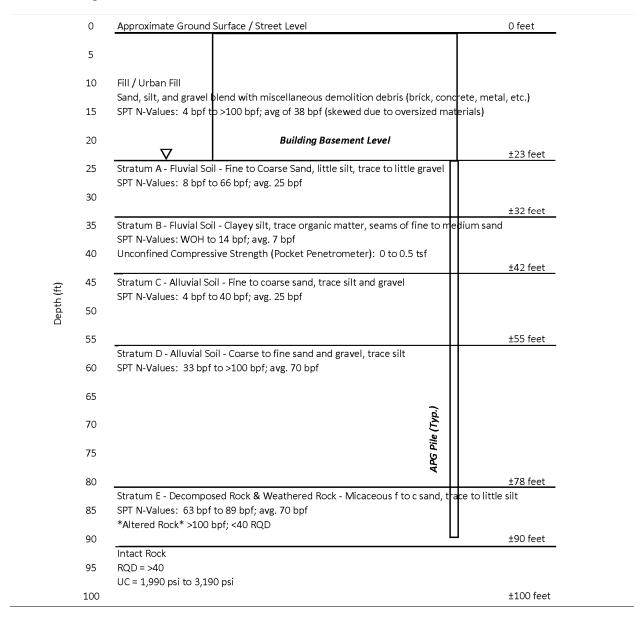
Figure 3. General Subsurface Profile (Gauffreau 2014).

Subsurface explorations conducted by the Geotechnical Engineer revealed a profile of urban fill / fill material [0 meters (0 feet) to ±7 meters (23 feet)], underlain sequentially by both fine- and coarse-grained fluvial deposits of a buried stream and marsh associated with the former Dock Creek [±7 meters (23 feet) to ±12.8 meters (42 feet)] and coarse-grained alluvial deposits of the Trenton Gravel Formation [±12.8 meters (42 feet) to ±23.8 meters (78 feet)], followed by a transitional zone of decomposed to weathered mica schist rock [±23.8 meters (78 feet) to ±27.4 meters (90 feet)]. Please refer to Figure 3 for an illustration of the generalized soil profile, including relevant standard penetration test (SPT) summary data.

Intact rock (defined by the Geotechnical Engineer as rock with a Rock Quality Designation greater than 40) was encountered at depths ranging from about 25 meters (82 feet) to 28.3 meters (93 feet) below ground surface, the surface of which generally sloped downward from south to north. Compressive strength test results on select rock core samples ranged from 13,720 kPa (1,990 psi) to 21,990 kPa (3,190 psi).

Groundwater at the site (according to two temporary groundwater piezometers) measured about \pm 7 meters (23 feet) below surface grades (elevation -1.2 meters (-4 feet)), corresponding with the historic marsh deposits. Seasonal high groundwater was estimated at elevation -0.6 meters (-2 feet) for design considerations.

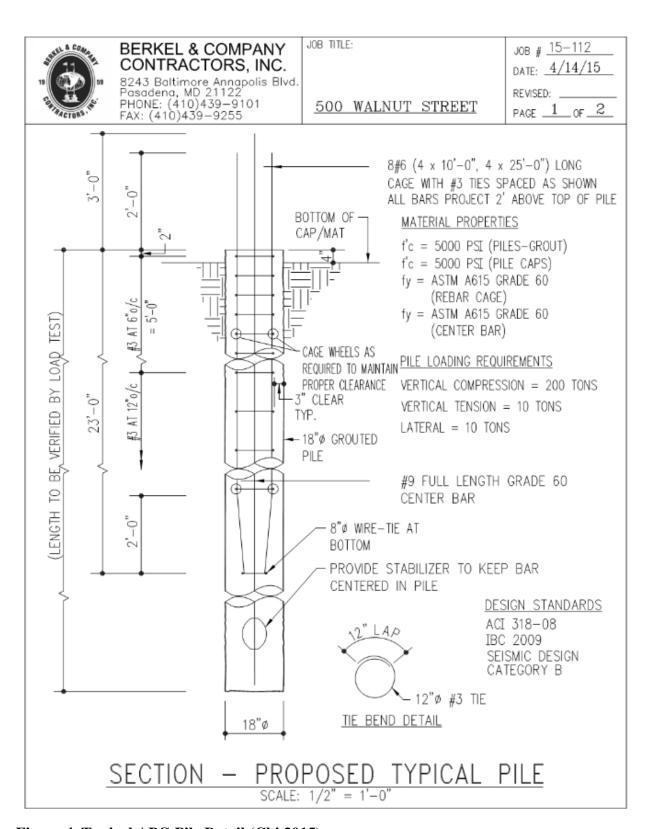
Figure 4. Typical APG Pile Detail (Chi 2015).

For economic reasons, the APG pile foundation contractor decided that two separate APG pile types would be installed. One pile type would be designed to resist only compression and lateral loads. The other pile type would be required to resist tension loads, as well as compression and lateral loads. Both pile types would have full length center bars installed, as well as a reinforcing steel cage installed in the upper 7 meters (23 feet) of the pile. However, the tension pile would have a much heavier #24 center bar that would be fully anchored into the concrete foundation pile cap above. Please refer to Figure 4 and Figure 5 for typical pile reinforcement details.

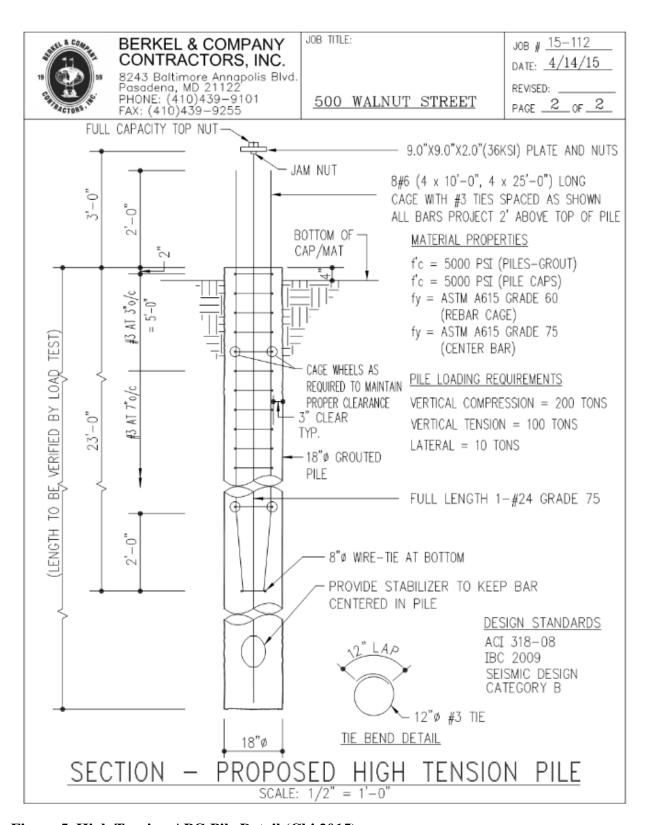
Figure 5. High Tension APG Pile Detail (Chi 2015).

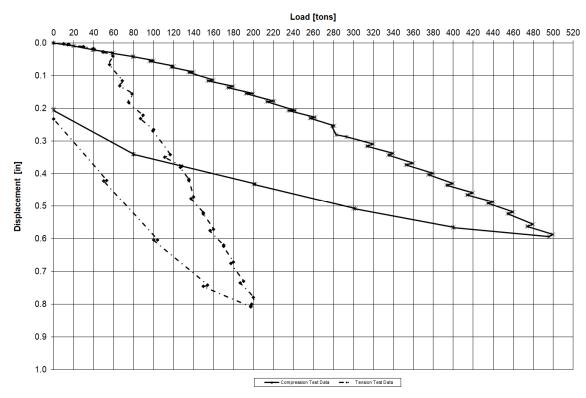
Figure 8. Applied Load vs. Pile-Head Deflection – Compression and Tension Pile Load Test (NeSmith 2015).

At the 1,780 kN (200-ton) test load, pile-head displacement was approximately 20.3 mm (0.8 inches), with no indication of geotechnical failure. At the design load of 890 kN (100 tons), the pile head displacement was approximately 6.6 mm (0.26 inches). Refer to Figure 8 for the pile load versus deflection data.

The tension test pile was considered to have an ultimate tensile or uplift capacity in excess of the maximum applied test load of 1,780 kN (200 tons). Plot of the displacement vs. load data produced a graph with two distinct slopes. A relatively flat slope before the 530 kN (60-ton) load increment, and a steeper slope after the 530 kN (60-ton) increment. The theoretical tensile cracking stress of the grout corresponds to a 530 kN (60-ton) applied load. Thus, the change in slope is considered to be the point at which the grout cracked, resulting in a change in the elastic response of the pile.

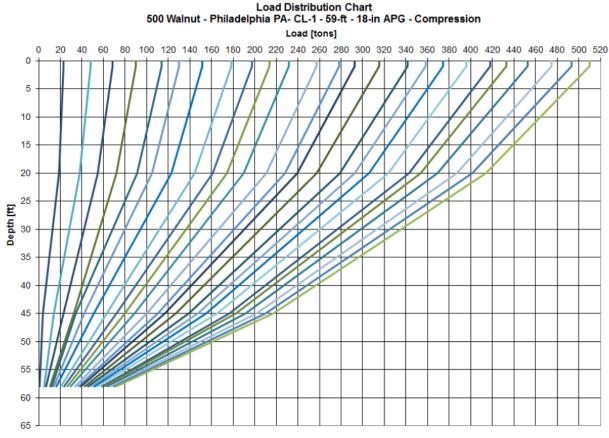
Figure 9. Load Distribution Chart - Compression Pile Load Test (NeSmith 2015).

Test pile shaft resistance was estimated from the available strain gauge data. Data at the gauge depths, measured in micro-strain, was converted to load using a pile-modulus estimated from the data of the gauge near the pile-top, where the applied load is known. The strain gauge data confirmed the assumed strength and stiffness of the various soil strata. As expected, the Trenton sand and gravel layer and the weathered mica schist layer generated significant side resistance. The strain gauge data did not indicate a significant end bearing component, likely because the pile toe did not experience enough movement to develop the end bearing capacity. Refer to Figure 9 for an illustration of the load distribution versus pile depth.

Loads were estimated from the strain gage field data as follows:

- Data from the strain gage read in digits.
- Microstrain estimated from the gage data in digits and the gage factor on the supplied calibration sheets
- Pile modulus estimated from known load at the top of the pile and data from strain gage near the pile-top
- Loads at remaining gage depths estimated from respective gage data and the pile modulus estimated above (Load = modulus * pile area * strain)

Pile capacity was evaluated per the Modified Davisson Offset Limit method. Based on the results of the load test, the test pile was considered to have an ultimate compression capacity in excess of the maximum applied test load of 4,450 kN (500 tons).

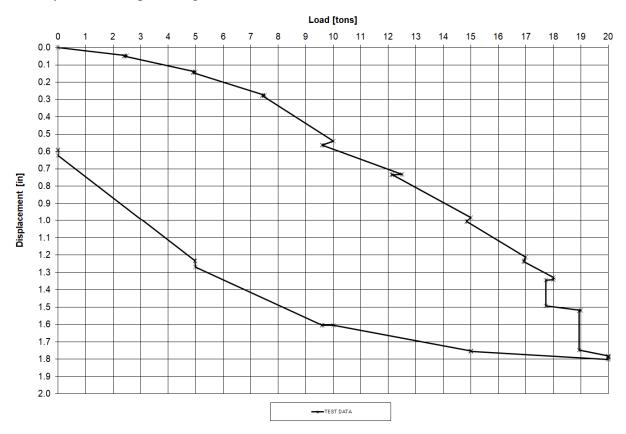
Figure 10. Applied Load vs. Pile-Head Deflection – Lateral Pile Load Test (NeSmith 2015).

The lateral test pile was tested to a load of 178 kN (20 tons, or 200% of the required allowable lateral load) in general accordance with ASTM D3966. At the 178 kN (20-ton) test load, pile-head displacement was approximately 45.7 mm (1.8 inches). At the design load of 89 kN (10 tons), the pile head displacement was approximately 14.0 mm (0.55 inches). Refer to Figure 10 for the pile load versus deflection data.

The lateral test pile condition did not match the same design conditions as production piles. The primary difference was that the test pile was tested in a free head condition, whereas the production piles are loaded in a fixed-head condition. Therefore, the lateral load test did not directly simulate the production pile condition. Instead, the lateral load test results were used to confirm the parameters used in the L-Pile analyses as a basis for the structural design of the production piles.

After completion of the lateral load test, an L-Pile model was constructed to model the pile under free-head conditions and mimic the lateral load test results, which resulted in realistic and verifiable design soil parameters. The L-Pile model was then changed to fixed-head to model the actual production piles. Group effects and top-of-pile level for production piles were also considered in the final design model. The lateral load test confirmed the validity of the original L-Pile analysis used for pile design.

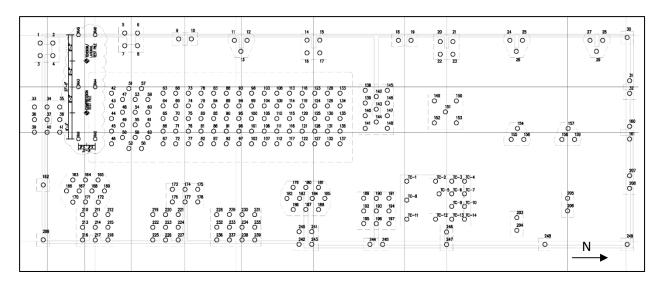
Figure 11. APG Pile Locations (Berkel 2015).

Production pile installation proceeded shortly after completion of the pile load test program and evaluation of the resulting data. Under normal operating conditions, the foundation contractor typically installed about 10 to 15 APG piles per day, with typical pile lengths ranging from about 19.8 meters (65 feet) to 24.4 meters (85 feet). In total, the foundation contractor installed 263 piles (249 piles for the building and an additional 14 piles for support of the tower crane) between July 1st and August 19th (approximate 7-week period). Figure 11 shows the layout of the APG piles for the building.

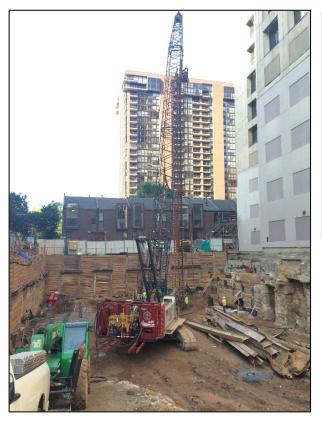
Figure 13. APG pile installation in progress.

The Geotechnical Engineer provided full-time construction observation, materials testing, and Special Inspections services on behalf of the Owner throughout construction of the piles. The APG pile foundation contractor also performed their own independent QA/QC. The production pile installation proceeded relatively uninterrupted and with limited issues. Photographs during installation of the APG pile installation are provided in Figures 12 and 13. Minor issues that were encountered during installation of the APG piles included:
