DFI Committee Project Funds (CPF)

Final Report  
**ACIP Pile Installation, Installation Monitoring,  
Full-scale Load Testing, and Extraction Program**

Augered Cast-In-Place (ACIP) Pile Committee

December 2017

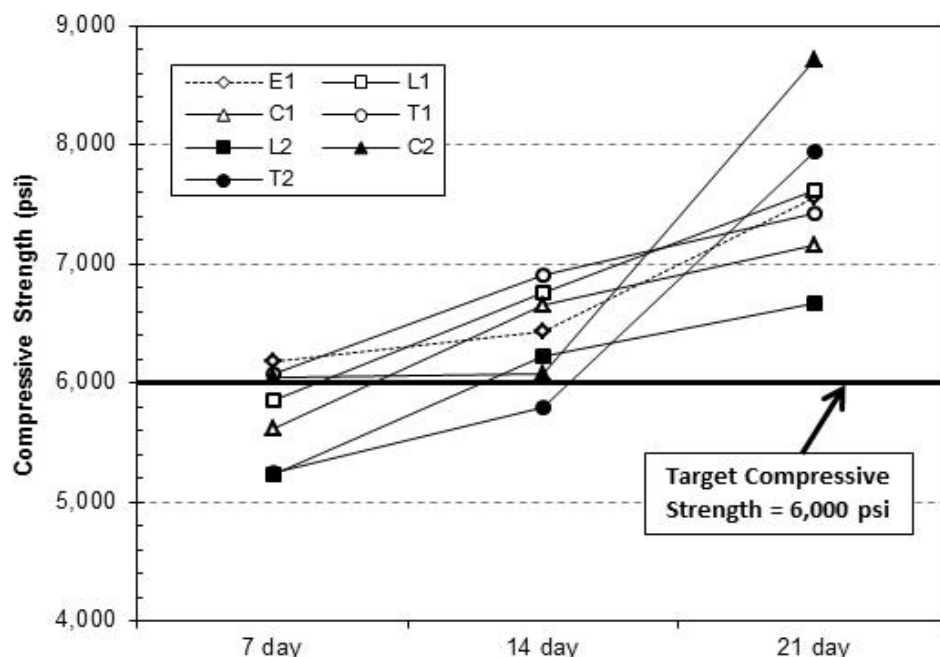
**Figure 13.** Compressive strength of grout at 7, 14, and 21 days

Pile Desig.	Sample No.	Compressive Strength of Grout					
		7 day		14 day		21 day	
		(psi)	(MPa)	(psi)	(MPa)	(psi)	(MPa)
E1	2	6173	42.6	6430	44.3	7560	52.1
L1	3	5860	40.4	6750	46.5	7610	52.5
C1	4	5620	38.7	6650	45.9	7160	49.4
T1	5	6070	41.9	6910	47.6	7430	51.2
L2	6	5230	36.1	6220	42.9	6670	46.0
C2	7	6040	41.6	6070	41.9	8710	60.1
T2	8	5250	36.2	5800	40.0	7940	54.7
Average		5749.0	39.6	6404.3	44.2	7582.9	52.3
Standard Deviation		390.5	2.7	397.3	2.7	637.0	4.4

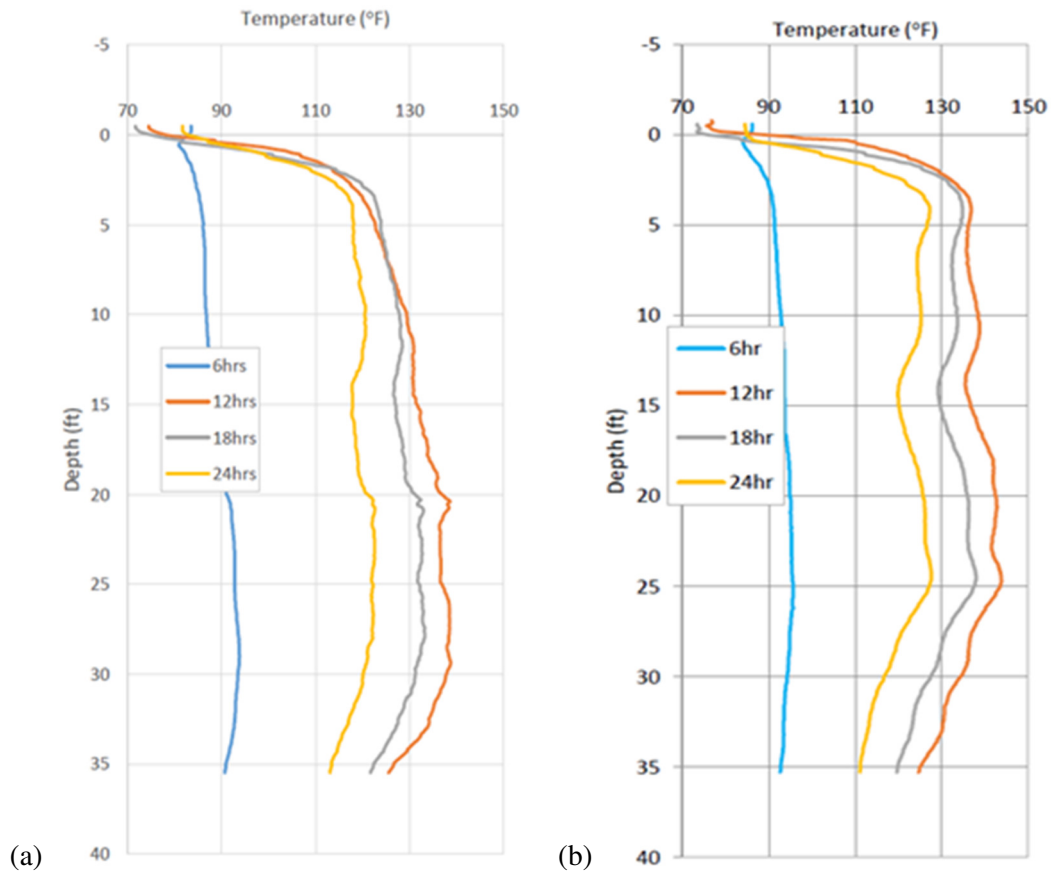
**Figure 15.** Thermal profiles at 6-hr intervals during curing at (a) test pile C-2 and (b) test pile L-2 (Mullins and Johnson, 2017)

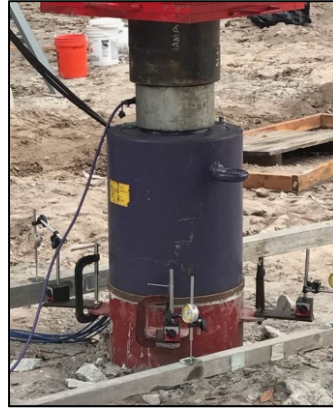
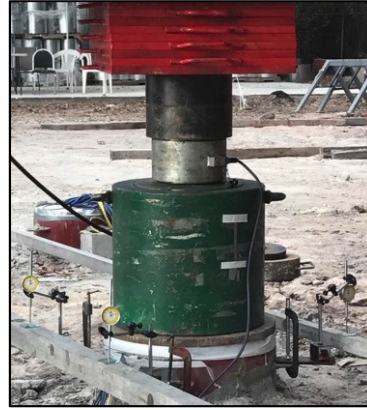
**Figure 20.** Compression load testing setup (hydraulic jack, load cell, and dial gages) for (a) pile C-1 and (b) pile C-2

The axial compression tests were performed in general accordance with ASTM D1143 / D1143M-07, Quick Load Method (ASTM, 2013a). As shown in Figures 19 and 20, axial compressive loads were applied manually using a hydraulic jack that was aligned concentrically with the installed piles (C-1 and C-2). During the loading phase, additional loads were applied in 15 ton (133 kN) increments at approximately 5 minute intervals. For each load increment, the applied load was increased to or above the target load (for that increment), and was maintained (i.e., no additional loads were applied) during the interval between readings. The applied loads were measured using a gage on the jack as well as an electronic load cell located between the pile and the reaction frame.

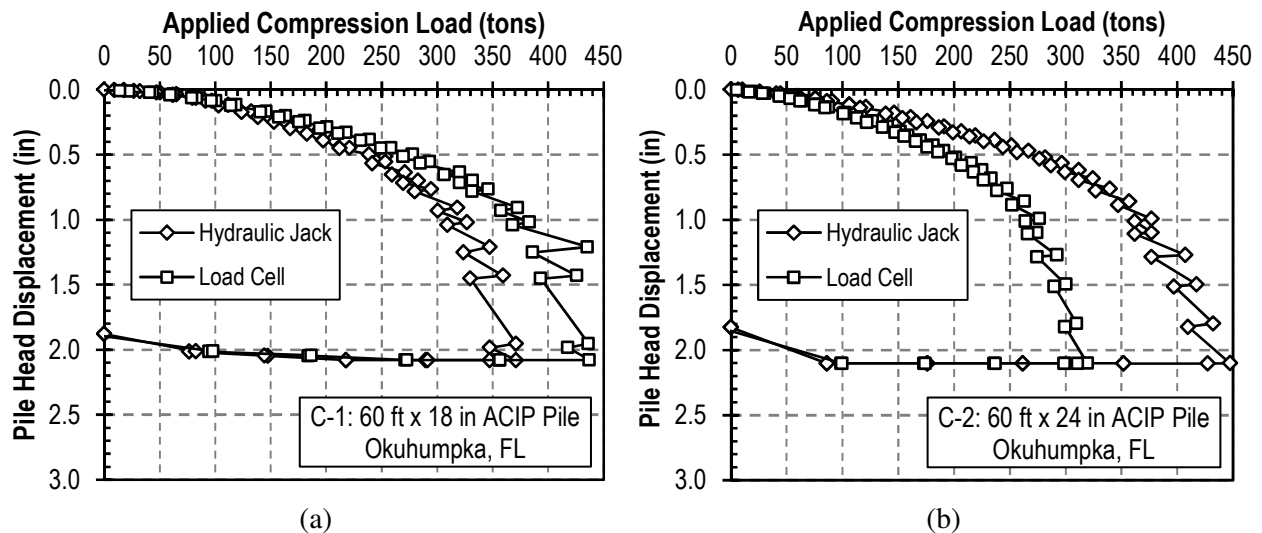
**Figure 21.** Load-displacement behavior of test piles (a) C-1 and (b) C-2 due to axial compression loading

The load-displacement responses of test piles C-1 and C-2 due to the applied axial compression loading are plotted in Figure 21. As observed in Figure 21 for both compression tests, there was poor agreement between loads determined using the hydraulic jack and the electronic load cell. This discrepancy was likely due to the electronic load cell, which is typically more precise in its measurements, but it is more susceptible to be negatively affected by changes in moisture and temperature and due to disturbance caused during transportation. Therefore, for the purposes of comparison for this demonstration project, only the results measured using the hydraulic jack will be considered (Figure 22); however, all of the data measured using the hydraulic jack and the electronic load cell during the testing are presented in Appendix I.

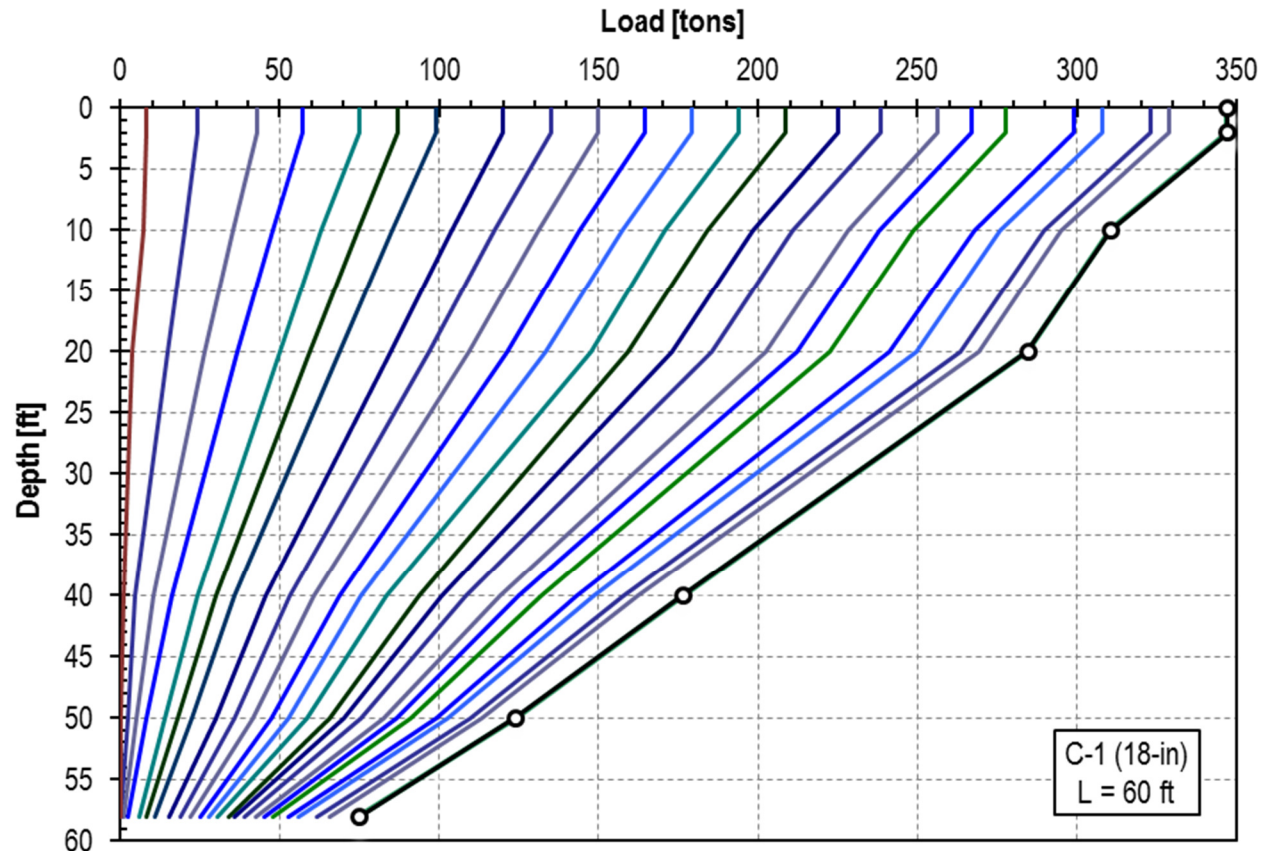
**Figure 23.** Load distribution (load transfer) curves for test pile C-1 due to compression loading based on strain gauge measurements during the axial compression loading

Strain Gauge No.					
	1	2	3	4	5	6
Depth (ft)	2	10	20	40	50	60
Incremental Length (ft)		8	10	20	10	10
Load at Strain Gauge (ton)						
Measured	347	311	285	177	124	75
Predicted	0	27	54	144	194	234
Shaft Resistance (ton)						
Measured	---	36	26	108	53	49
Predicted	---	27	27	90	50	40
Unit Side Resistance (ton/sq ft)						
Measured	---	0.966	0.552	1.146	1.117	1.303
Predicted	---	0.716	0.573	0.955	1.061	1.061

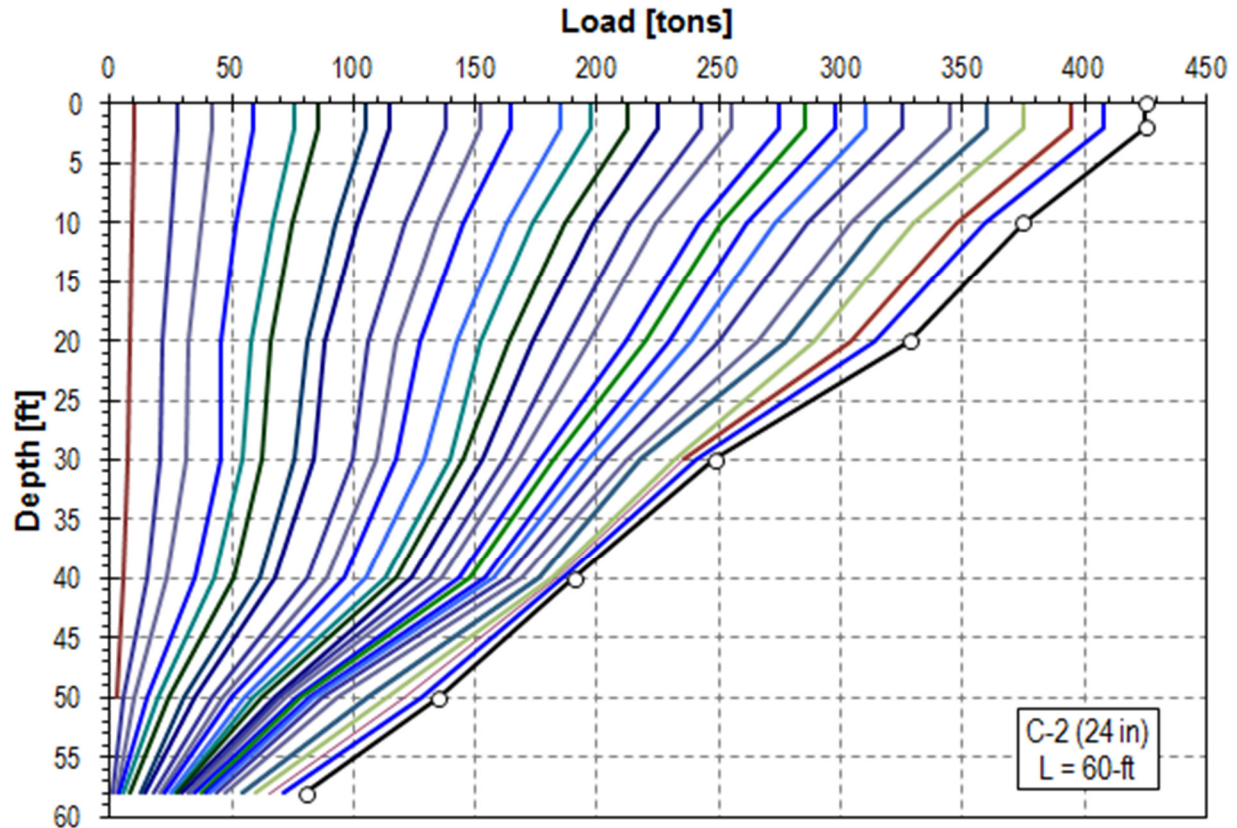
**Figure 24.** Load distribution (load transfer) curves for test pile C-2 due to compression loading based on strain gauge measurements during the axial compression loading

Strain Gauge No.						
	1	2	3	4	5	6	7
Depth (ft)	2	10	20	30	40	50	58
Incremental Length (ft)		8	10	10	10	10	8
Load at Strain Gauge (ton)							
Measured	425	375	328	248	191	135	80
Predicted	0	36	72	132	194	261	315
Shaft Resistance (ton)							
Measured	---	50	46	80	58	56	55
Predicted	---	36	36	60	63	67	54
Unit Side Resistance (ton/sq ft)							
Measured	---	1.002	0.737	1.274	0.918	0.887	1.085
Predicted	---	0.722	0.568	0.947	0.996	1.058	1.082

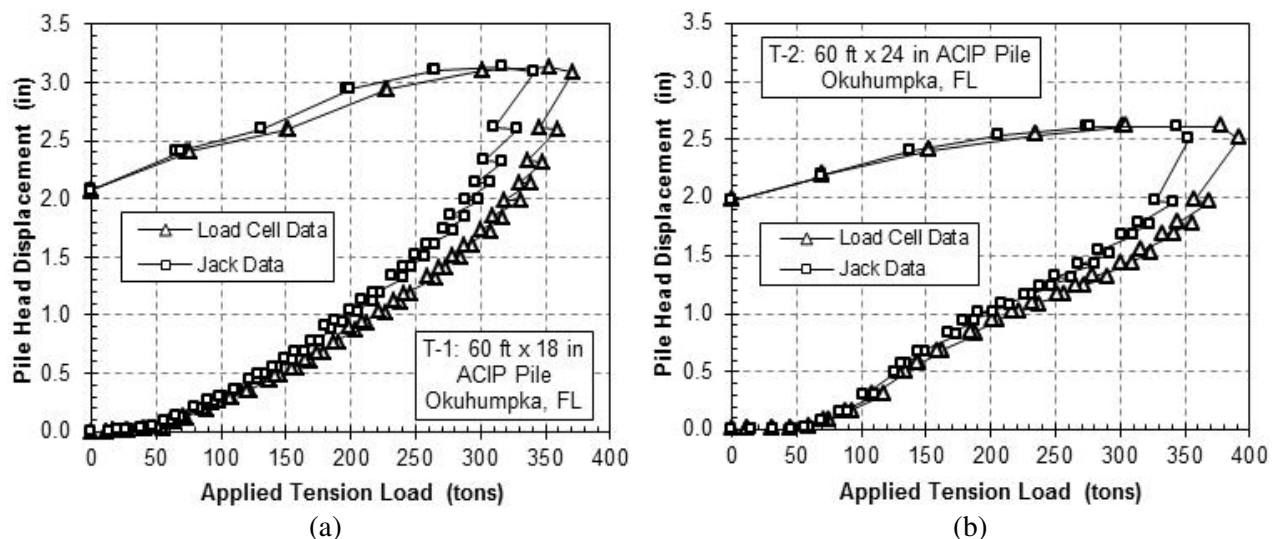
**Figure 26.** Load-displacement behavior of test piles (a) T-1 and (b) T-2 due to tension loading

The load-displacement responses of test piles T-1 and T-2 due to the applied axial tension loading are plotted in Figure 26, and all of the data measured using the hydraulic jack and the electronic load cell during the tension testing are presented in Appendix J. The estimated capacity of test piles T-1 and T-2 were computed as 205 ton (1824 kN) and 265 ton (2538 kN), respectively. As observed in Figure 26 for both tension tests, there was better agreement between loads determined using the hydraulic jack and the electronic load cell than was observed for the compression tests (Figure 21).

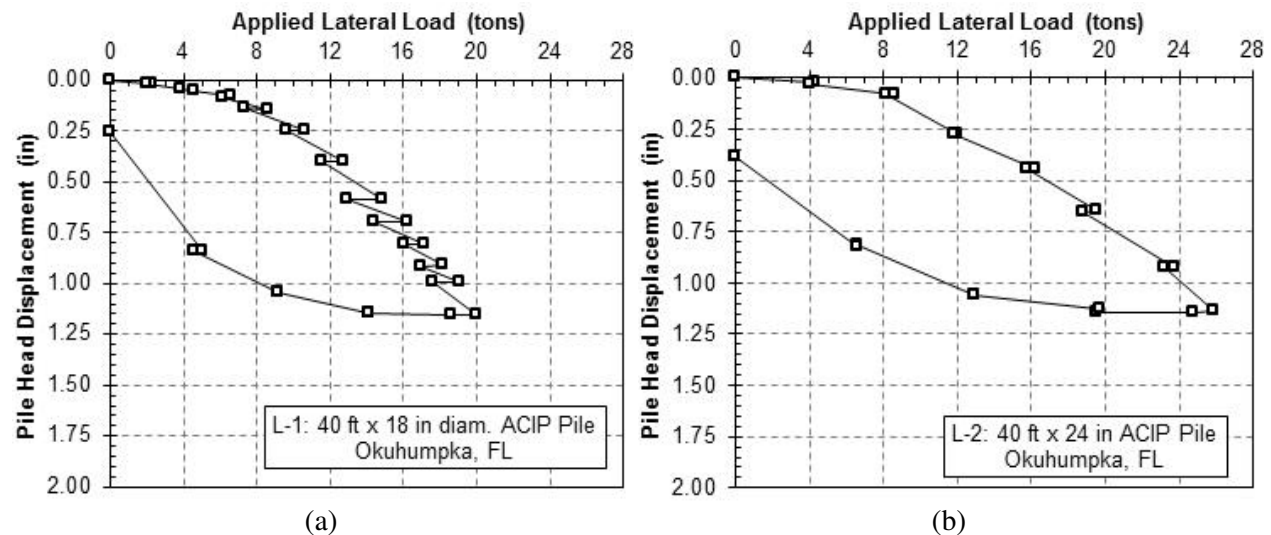
**Figure 28.** Load-displacement behavior of test piles (a) L-1 and (b) L-2 due to lateral loading

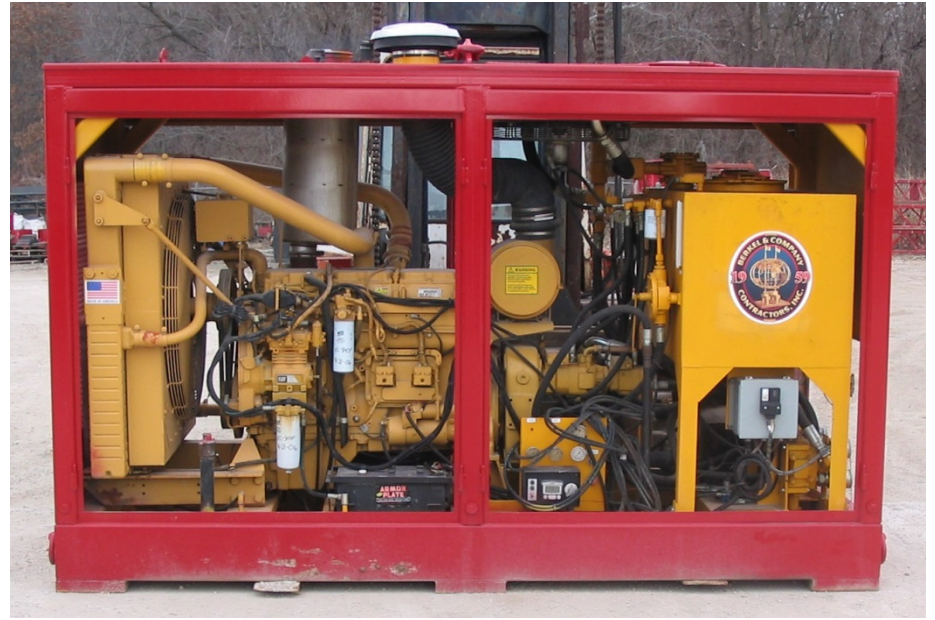
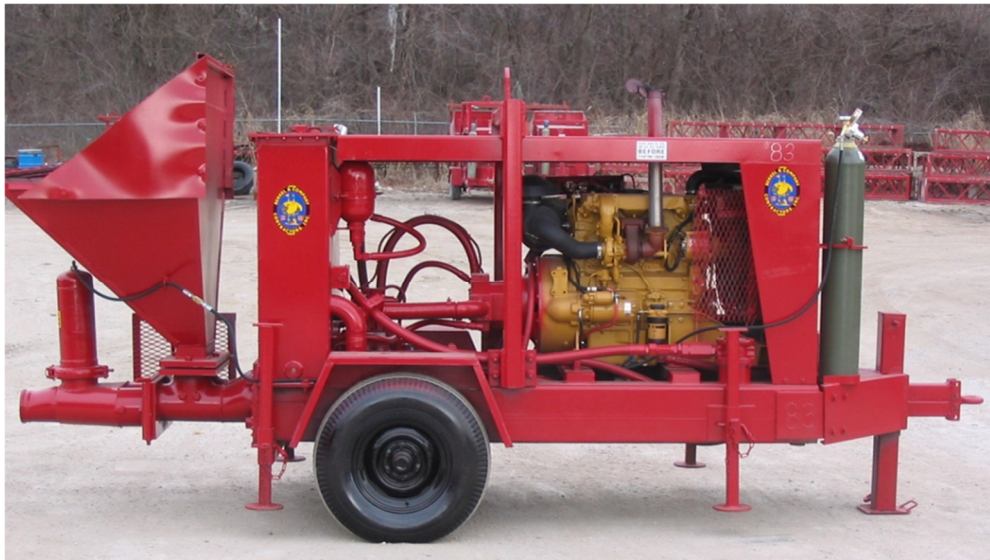
**Figure D-1.** Photographs of drilling platform components : (a) gear box, (b) hydraulic power unit, and (c) grout pump
