# Verification of Installation and Performance of ACIP Piles for Bridges

W. MORGAN NESMITH, BERKEL, Atlanta GA

IBC 17-65

**ABSTRACT:** The DFI ACIP Pile Committee, in conjunction with the Florida DOT, completed an ACIP Pile installation monitoring and performance test program in late 2016 to advance the inclusion of ACIP piles in future specifications for bridges by state agencies. Piles of different diameters were installed for compression, tension and lateral testing, and one pile was extracted for visual inspection. This paper presents the pile installation, non-destructive testing and load test results of the program.

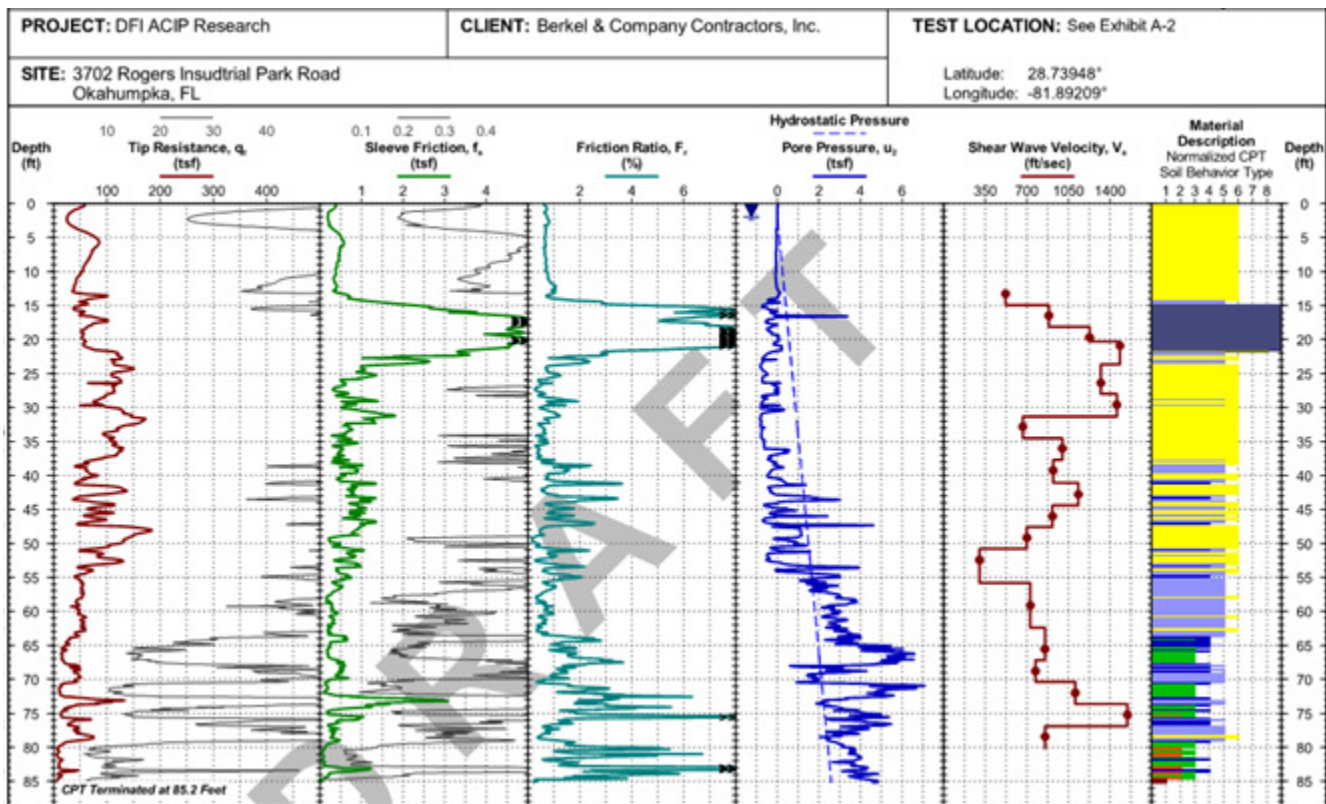
Figure 2 – CPT R-6

A general program location map along with an aerial view of the property in Okahumpka FL is shown in Figure 1. Two Cone Penetration Tests (CPT) were performed at initial reaction pile locations R-6 and R-8 (Figures 2 and 3)

The results from CPT R-6 indicated very loose soil conditions at depths below 55-ft, indicating potential relic sinkhole conditions. The test layout was subsequently rotated and moved south of CPT R-8.

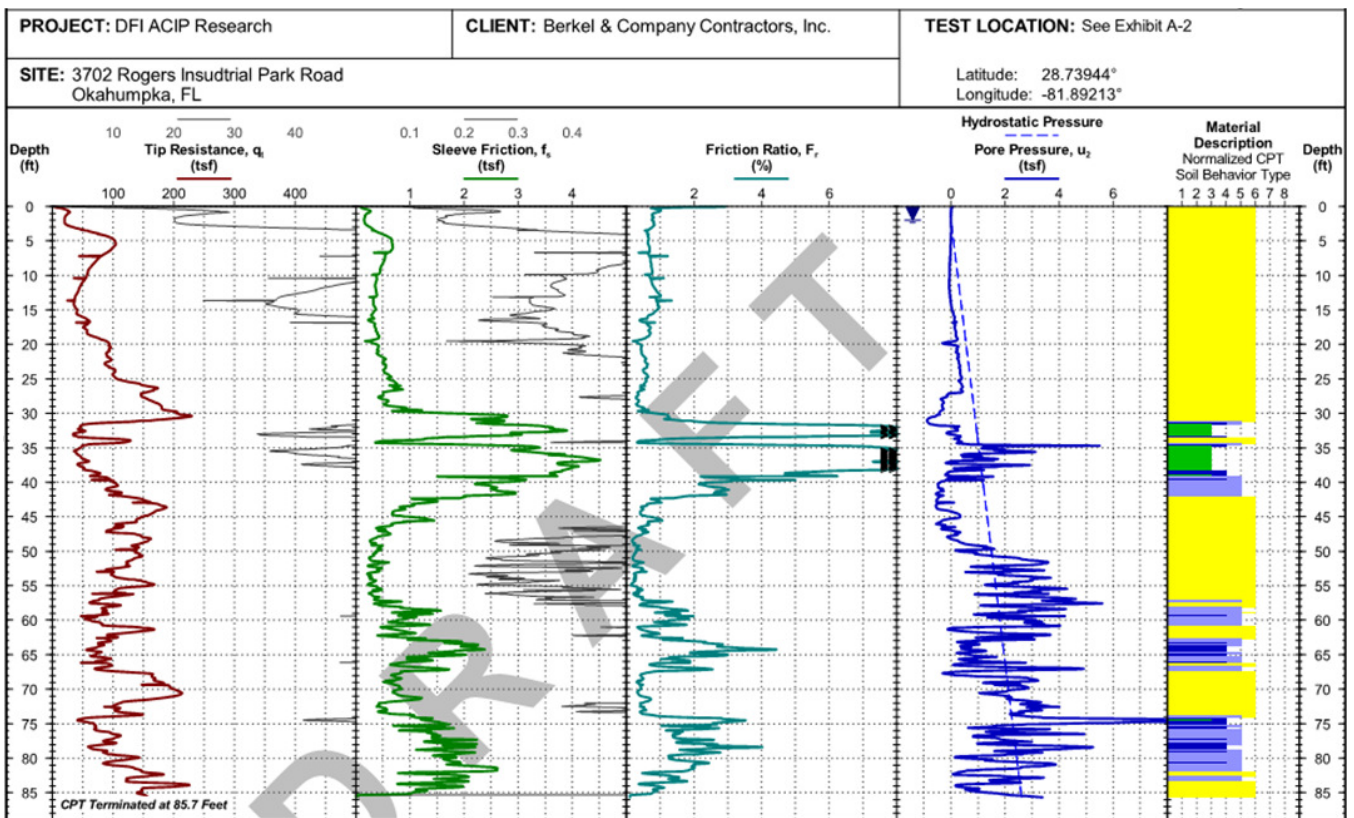
Figure 3- CPT R-8

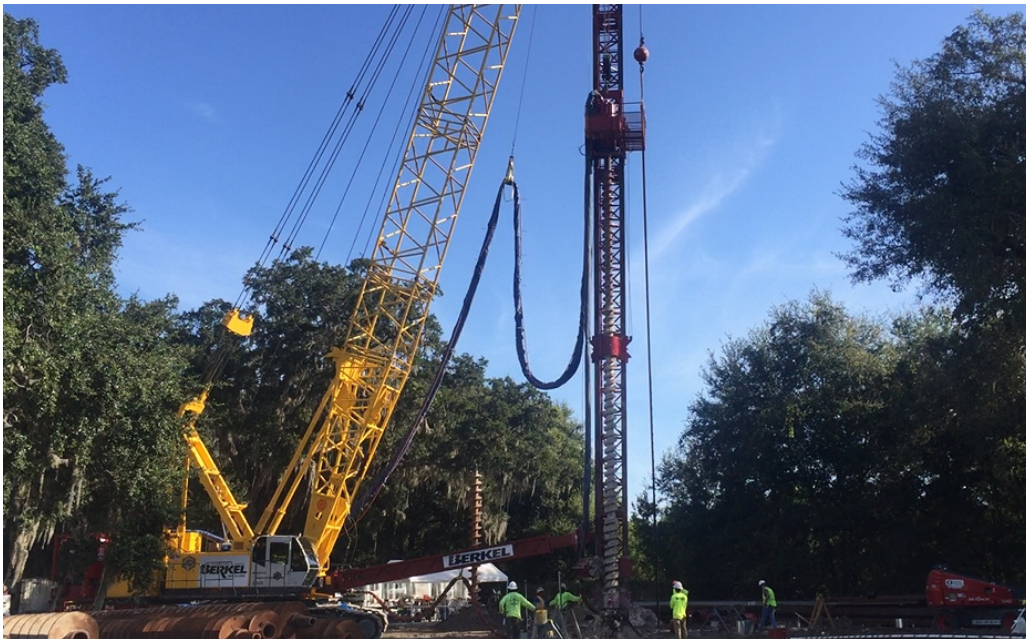
Figure 4 – Installation Platform and ACIP Pile Drilling Equipment

Figure 4 is a photograph of the project installation platform and installation equipment. A 750-horsepower hydraulic power unit was mounted on the back of the crawler crane. A gearbox with about 75,000 ft-lbs of maximum torque was attached to the swinging leads suspended from the crane boom.

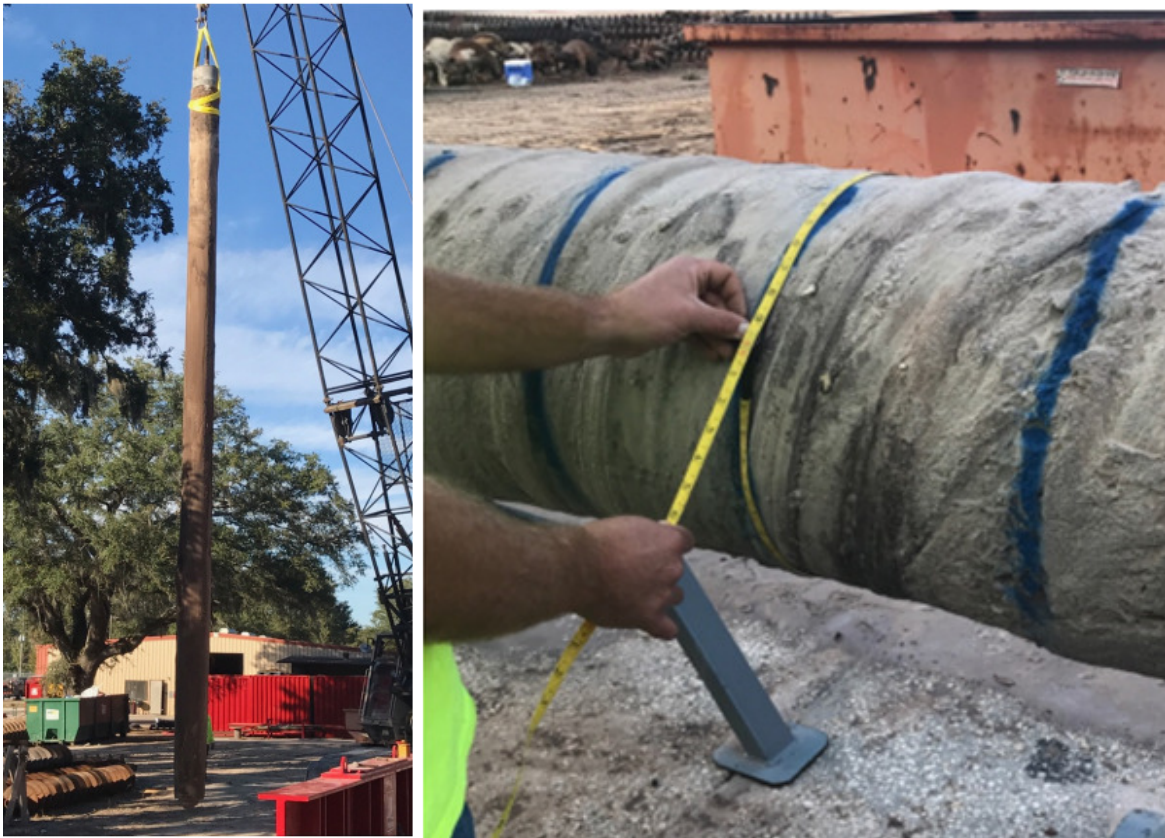
Figure 14 – Extracted 18-in diameter ACIP Pile for Manual Circumference Readings

One 18-in diameter pile was extracted to manually measure circumference. The pile was pressure-washed as it was extracted, laid horizontally for inspection and circumference was measured at 1-ft intervals (Figure 14). The average interpreted diameter was calculated as 19.2-in. For comparison, the TIP results from the extraction pile are presented in Figure 15. In addition to showing a relatively uniform temperature, indicative of a uniform pile diameter, the interpreted diameters with depth, when adjusted for the volume of grout observed coming out of the ground during installation, show excellent agreement with the manually calculated diameters. A full report of the TIP program for this project will be published by 31 August 2017.
