GEORGE HARMS CONSTRUCTION CO. INSTALLS 240-FOOT DRILLED SHAFTS

AWARD WINNING MICROPILE SUPPORT OF HISTORIC STRUCTURES IN THE U.S. CAPITAL

INTRODUCTION

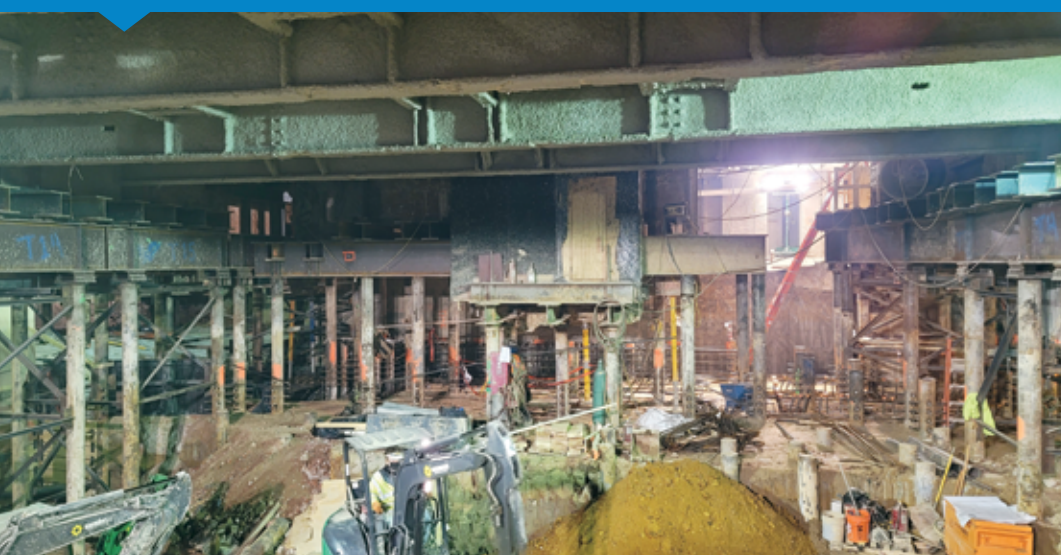
FIGURE 2: MICROPILE TRUSS TOWER FOR INTERIOR BEARING WALL AND BANK VAULT DOOR SUPPORT

Micropiles with outside diameters (OD) of 9-7/8 inches and 11 7/8 inches were selected to serve as the permanent foundation system for the new constructions and the temporary load transfer system from the existing foundations to the new support system. Permanent micropiles were utilized as trussed towers with needle beams and load transfer beams to temporarily support the existing bearing wall as shown in Figure 2.

In addition to supporting the existing bearing walls, a 40-ton historic bank vault door was required to be stabilized and supported. Compression and tension micropiles with jacking beams were installed beneath the door to provide this support (Figure 2).

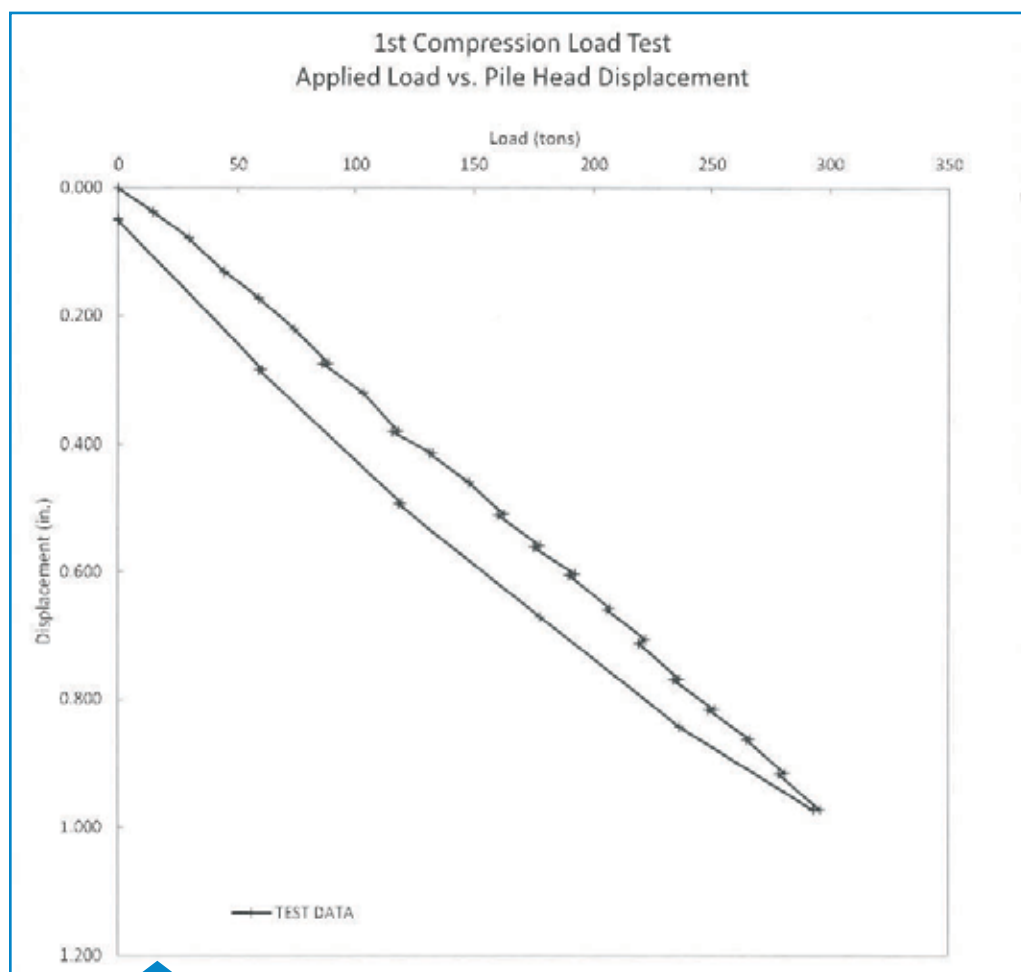
FIGURE 3: LOAD SETTLEMENT CURVE IN LOAD TEST REPORT BY BERKEL

As shown in the Figure 3, the total displacement at the design load of 148 tons was about 0.4 inch. The net displacement at the conclusion of the test, after all load had been removed, was about 0.05 inch. Considering that the load and unload response of the micropile was primarily linear, elastic, and recoverable, the mobilized bond stresses in the rock sockets appear to be still within serviceable limits and do not represent ultimate or failure conditions. Per the load test results, it was confirmed that the installed test micropile could support the design compression load with a factor of safety of at least 2.

Two static compression load tests were performed in general accordance with ASTM D1143 Quick Load Test Procedures and Load Testing Setup requirements. The pile compression design load was 148 tons, and the piles were loaded to a maximum load of 296 tons (in increments of approximately 15 tons). The test piles were installed from the existing basement level at El. 41.8 feet by advancing

approximately 80 feet of 9.875-inch diameter (0.625 inch thickness, API N80) casing with a 15-ft rock socket that was 10.3 inches in diameter.

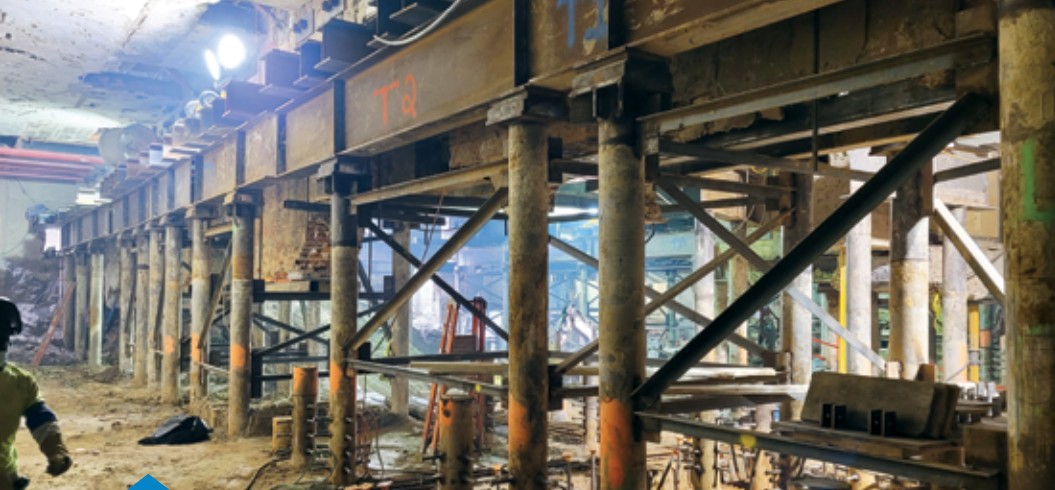
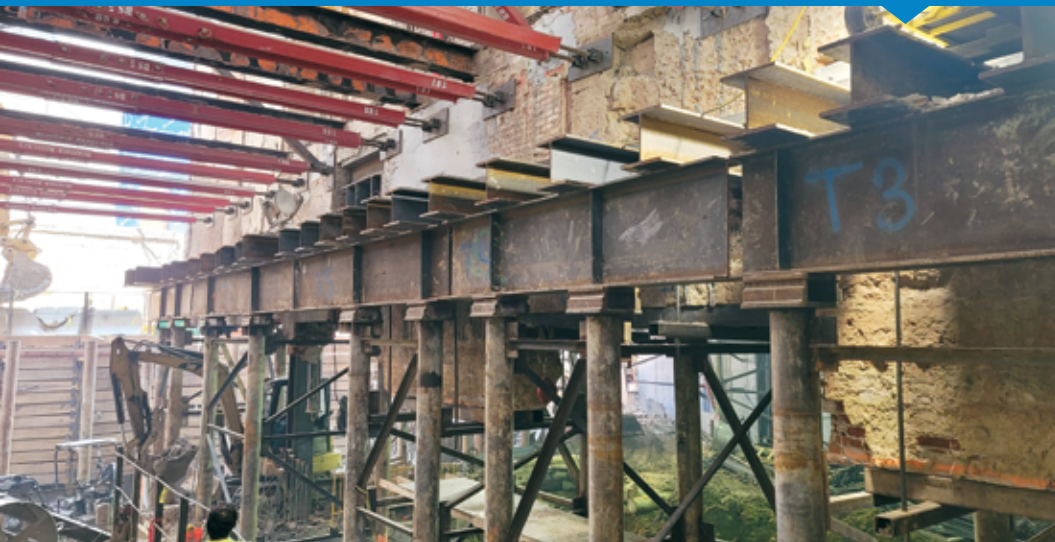
FIGURE 4: MICROPILE TRUSS TOWER CONSTRUCTION DURING EXCAVATION IN PROGRESS

More than three hundred micropiles with 9 7/8-inch casing, with section lengths of 3 feet to 5 feet, were installed with about 8.5 feet of headroom. These micropiles were installed along the two bearing walls and were utilized as shoring towers as shown in Figure 4.

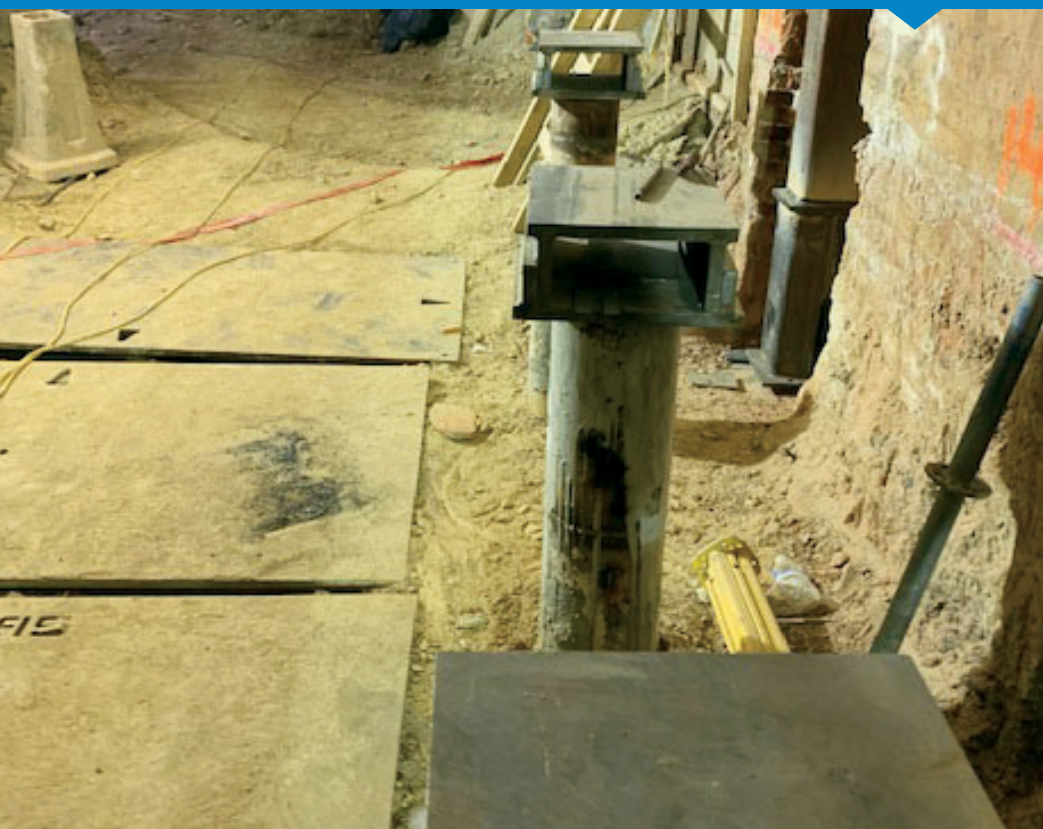
FIGURE 5: DETAIL OF SUPPORTING BRACKET ON TOP OF MICROPILE

Each shoring tower consisted of four micropiles called jacking piles and a supporting bracket was constructed on top of each jacking pile. The supporting bracket was designed to apply preloading in the existing bearing wall with low-height hydraulic jacks prior to the new pile cap and bearing wall construction.

Four hydraulic jacks were placed in the supporting brackets. Reference beams and two monitoring gauges (one each side of the existing bearing wall) were installed at midspan between jacking piles. Construction activities were strictly controlled during the entire jacking procedure.

Preloading was applied simultaneously to all installed

jacks in increments of five percent of the target jacking load. The jacking process was monitored to limit the upward movement to less than 1/16 inch or the maximum target jacking load to ensure that the target service load of the new bearing wall had been transferred to the existing bearing wall (Figure 5).
